**PITTSBURGH GEOLOGICAL SOCIETY
GOLDEN ANNIVERSARY (1945 - 1995)
FIELD GUIDE BOOK
1995**

**THE PITTSBURGH GEOLOGICAL SOCIETY
GOLDEN ANNIVERSARY (1945-1995)
FIELD TRIP**

Geology of Western Pennsylvania

FOUNDATION TREATMENT FOR LITTLE BLUE RUN DAM

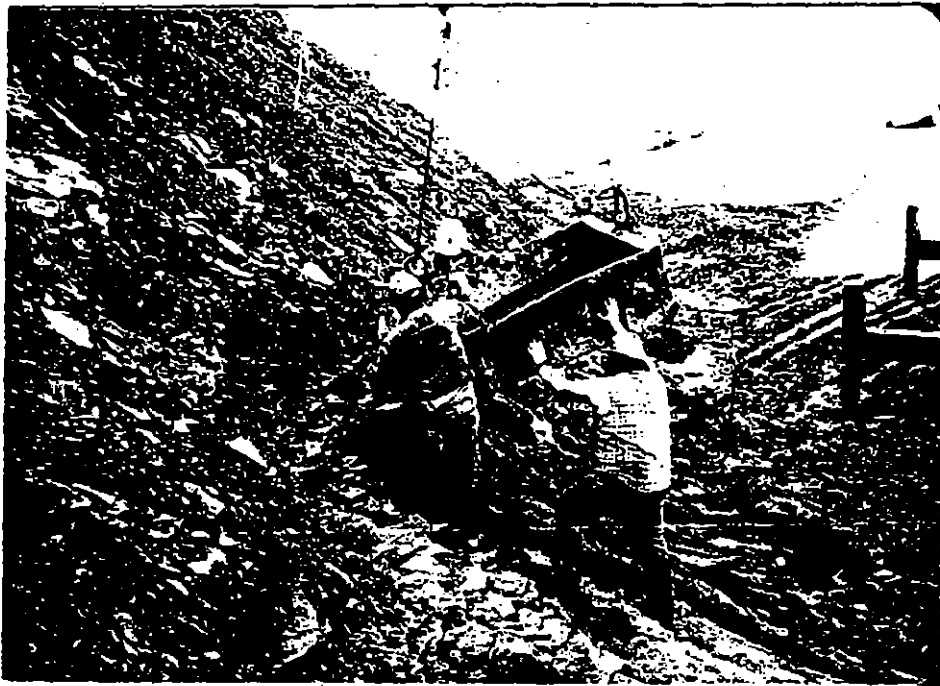
FIGURE 11 - SEALING JOINTS WITH SLUSH GROUT
