Pittsburgh Geological Society
75th Anniversary Field Trip
March 2022

Interstate Route 79 and Toms Run Nature Reserve
Landslide Areas North of the Ohio River and
Northwest of Pittsburgh

I-79 Station 916-918 Progressive Failure of Colluvial Slope – March 13, 1969

Field Trip Leader: James V. Hamel, Ph.D., P.E., P.G.
PGS Honorary Member

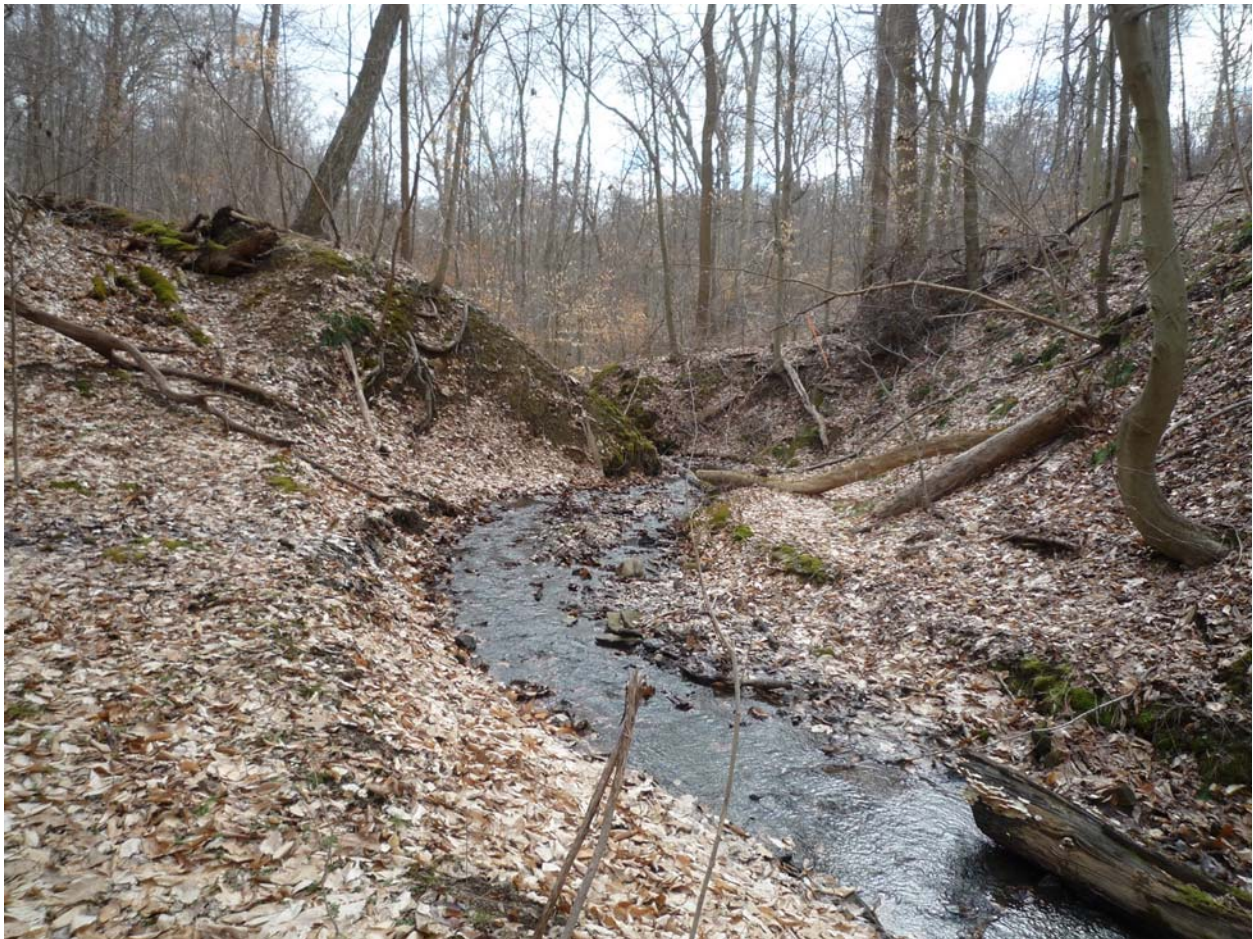
Figure 11. View upstream (west) at the stream eroding the toe of the slide mass on the left, with a tree bent from creep and sliding on the right.

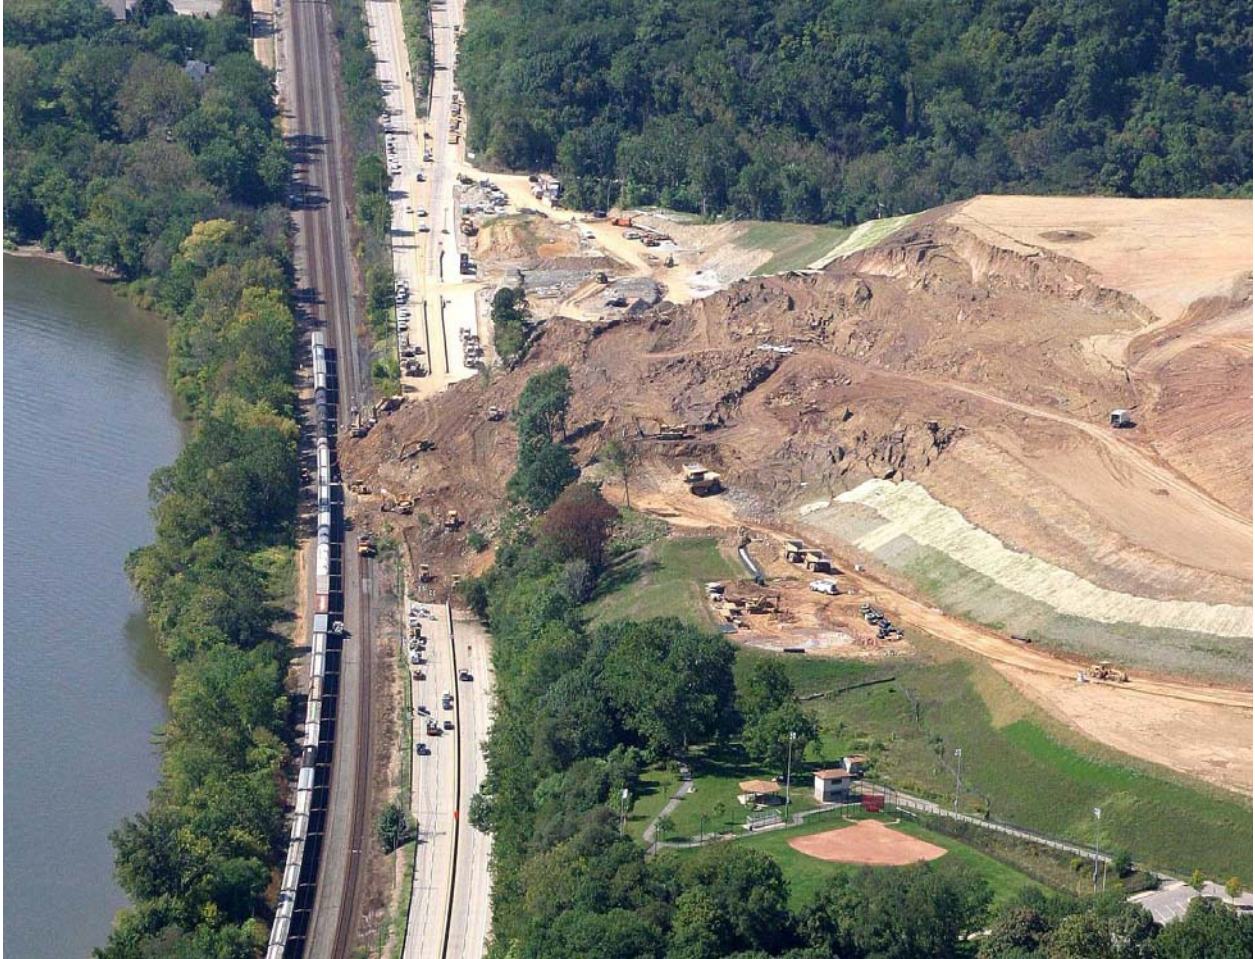
Figure 12. Oblique aerial photograph of the Kilbuck landslide, taken September 19, 2006 (Pennsylvania Department of Transportation).

Grading and other site work began in March 2006. On April 26, 2006, blasting caused a rock slide that temporarily closed Ohio River Boulevard. During the spring and summer of 2006, up to 100 ft. of fill was placed over colluvium which had not been recognized and/or had been ignored during site investigation and design. Relatively small landslides of unspecified size and location occurred in July and early September 2006. Heavy blasting of rock on September 18, 2006, may have contributed to initiation of the large landslide on September 19, 2006.

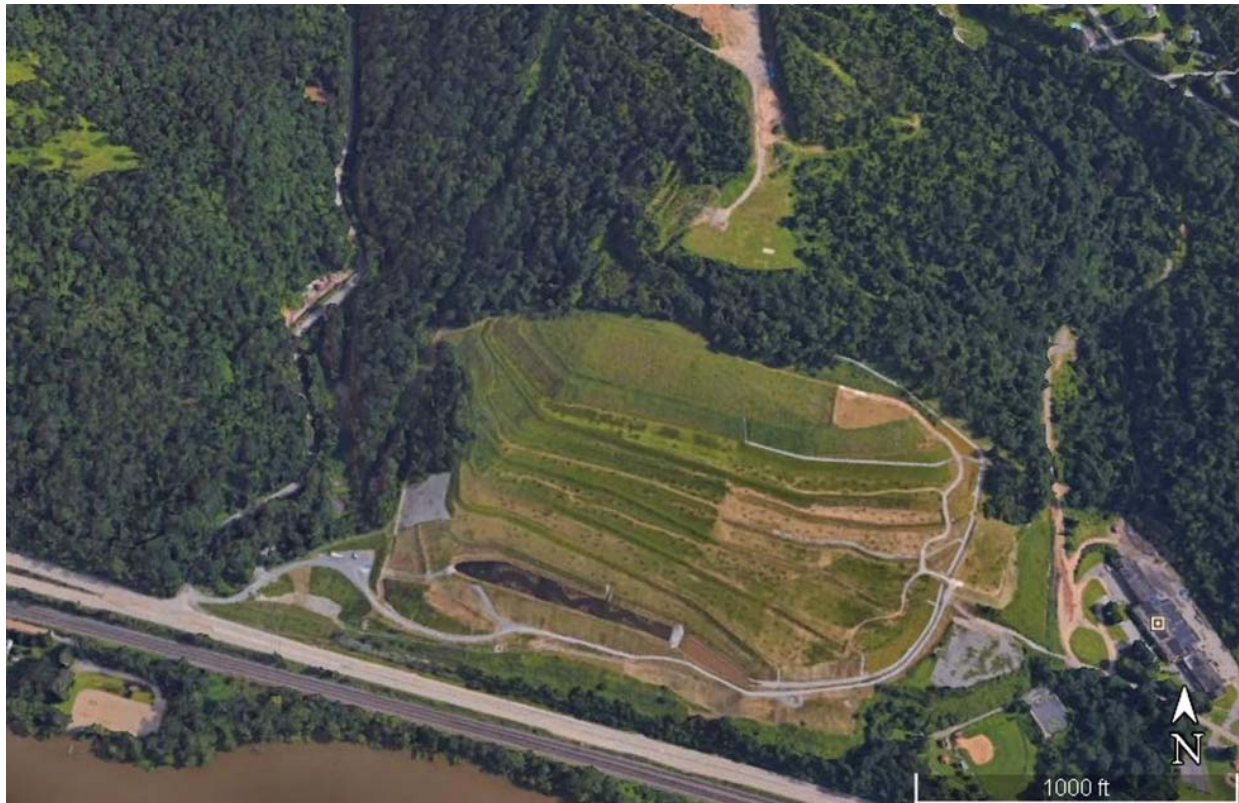
Figure 13. Google Earth photo of the restored Kilbuck Landslide site.

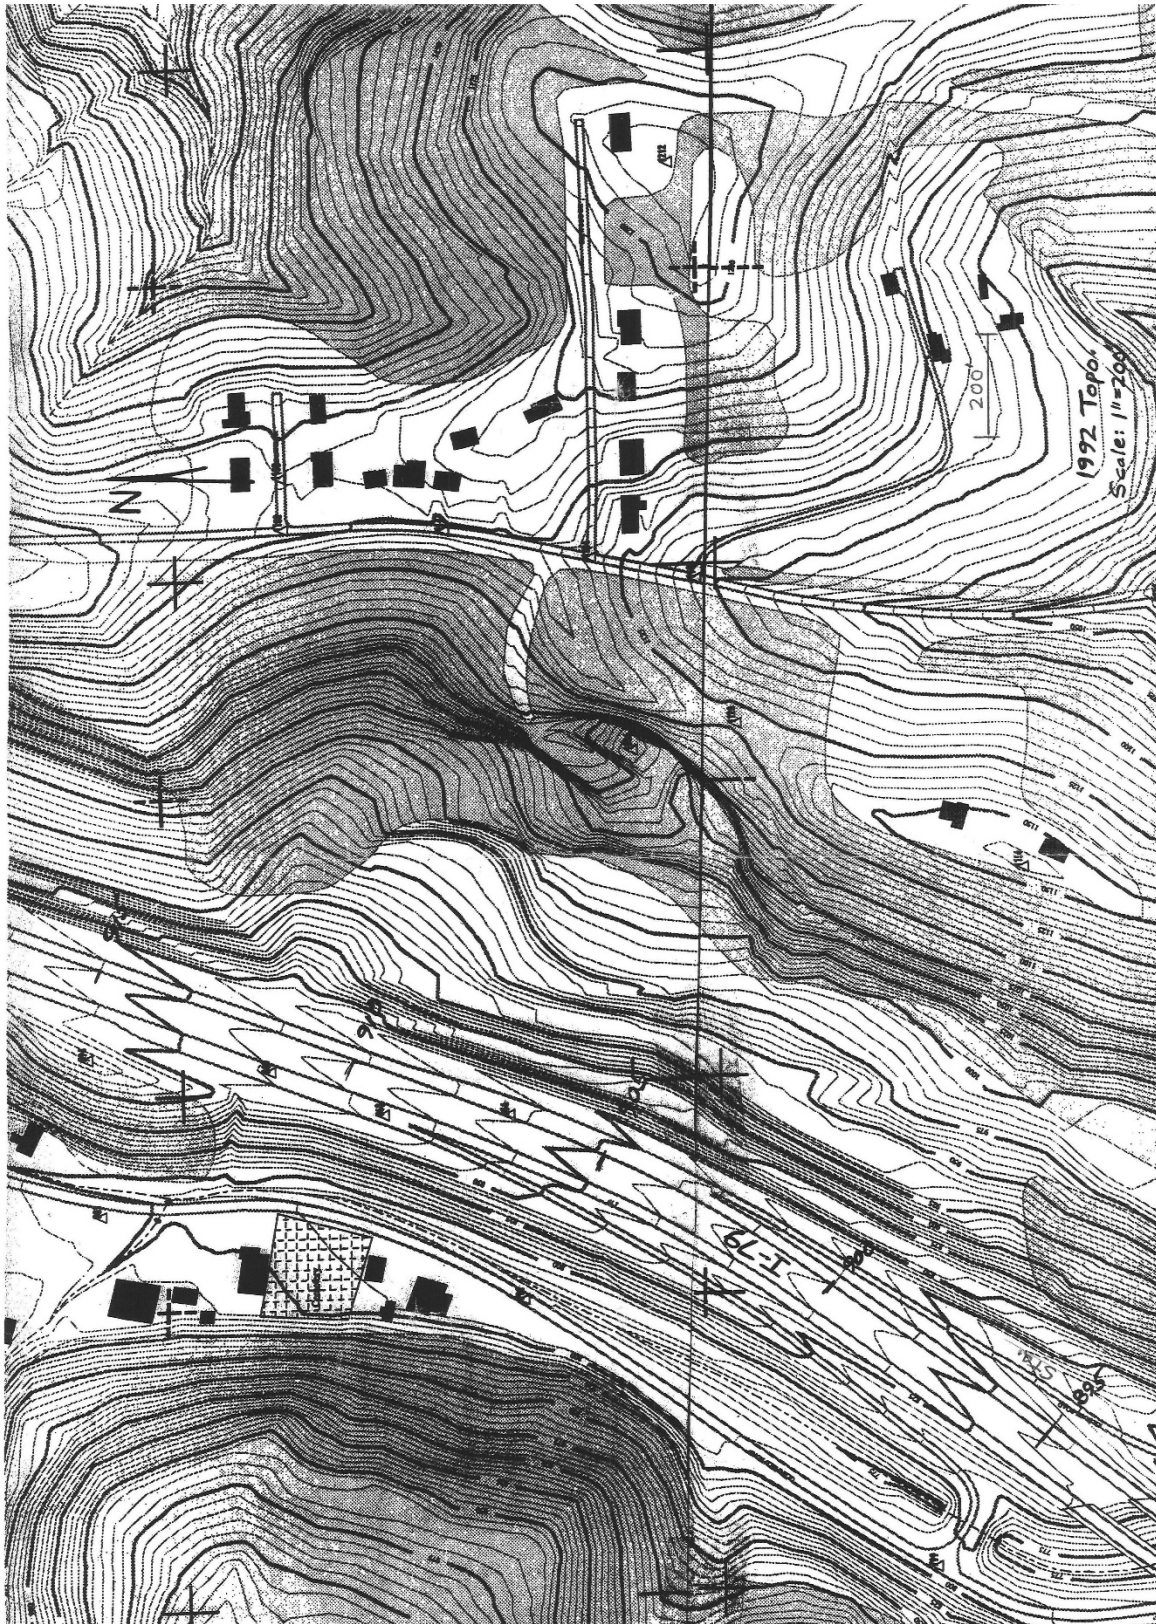
Figure 14. Annotated portion of 1992 Allegheny County topographic map showing features at Stop 4 (modified slightly from Gray, et al., 2011, Figure 23).

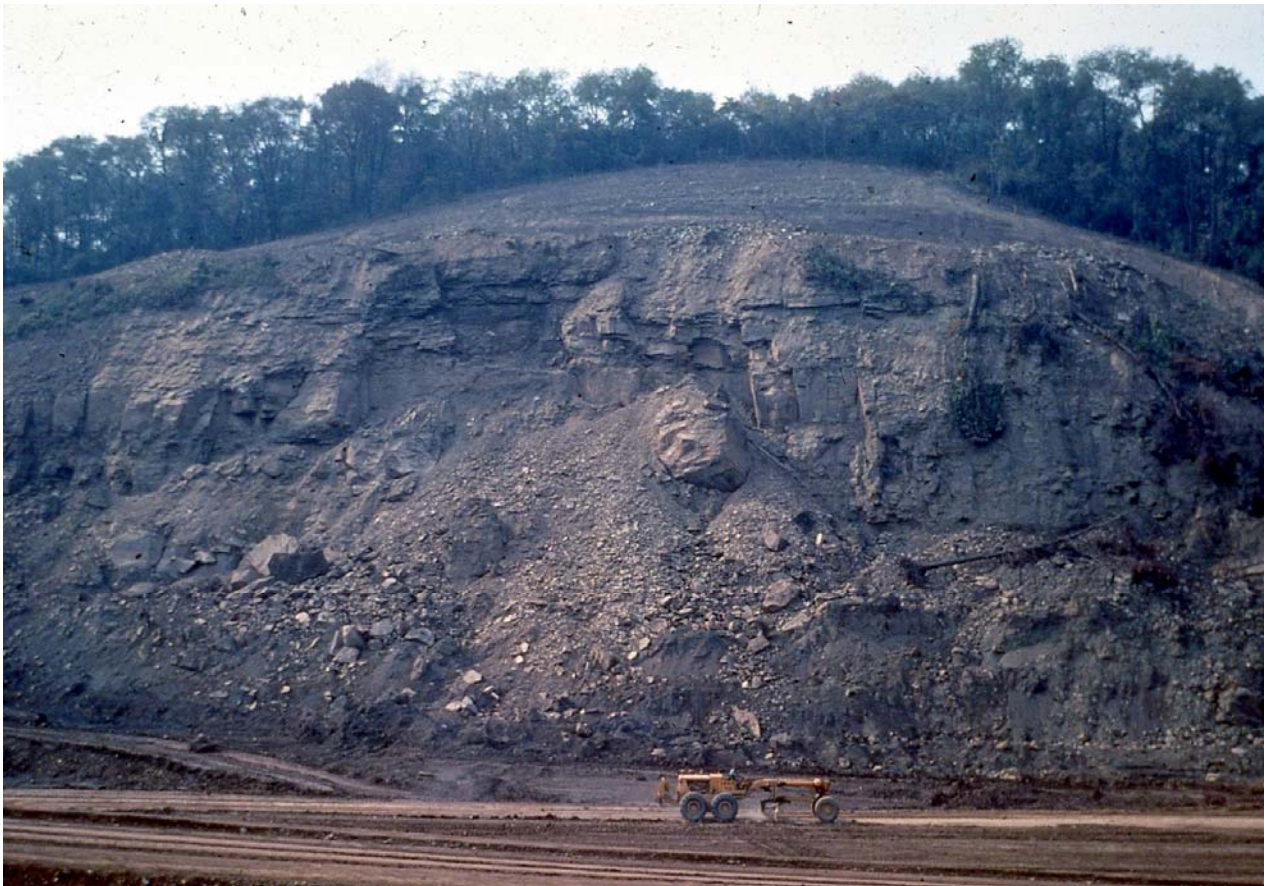
Photo of a rockslide, I-79 Sta 990, October 11, 1968.

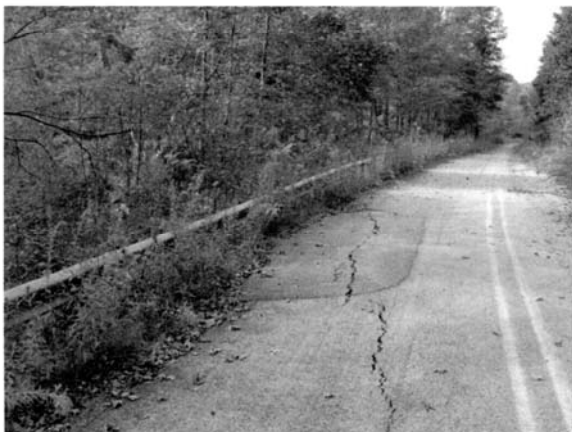
Figure 13. View of Landslide No. 3 looking east.

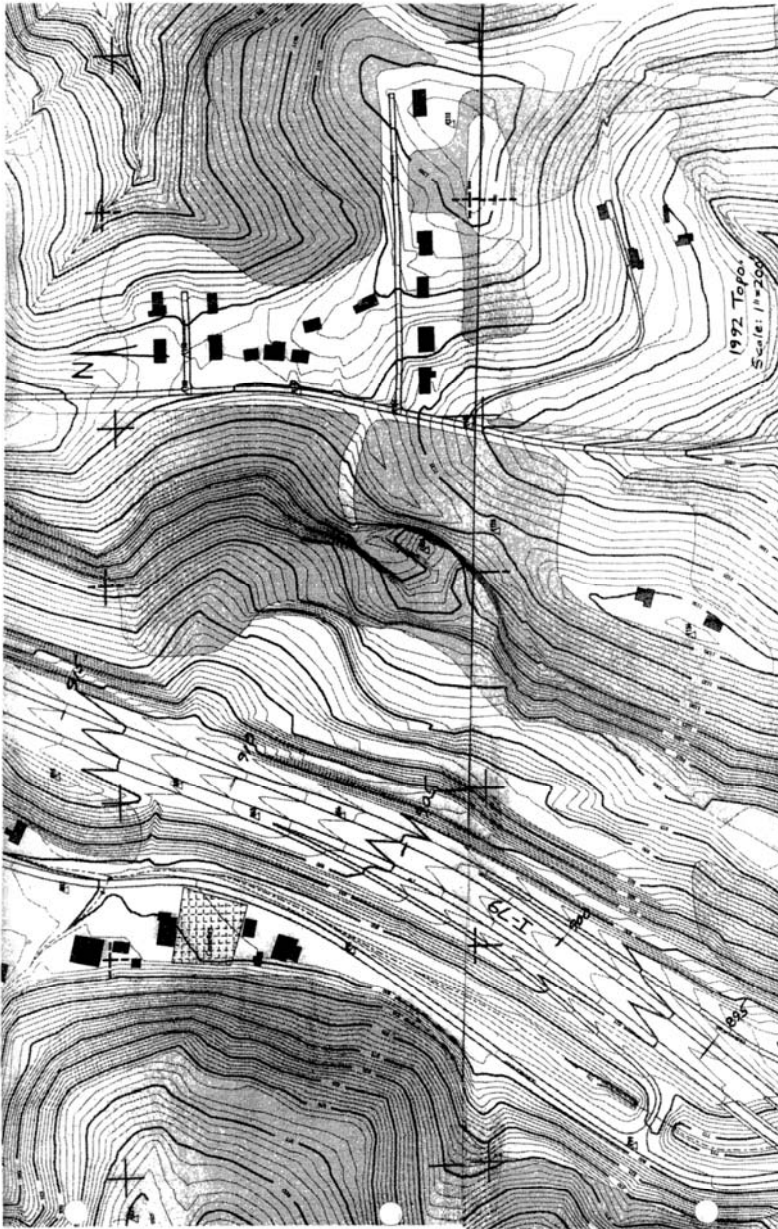
Figure 23. Plan, Stop 4 (on portion of Allegheny County Topographic Map, 1992).

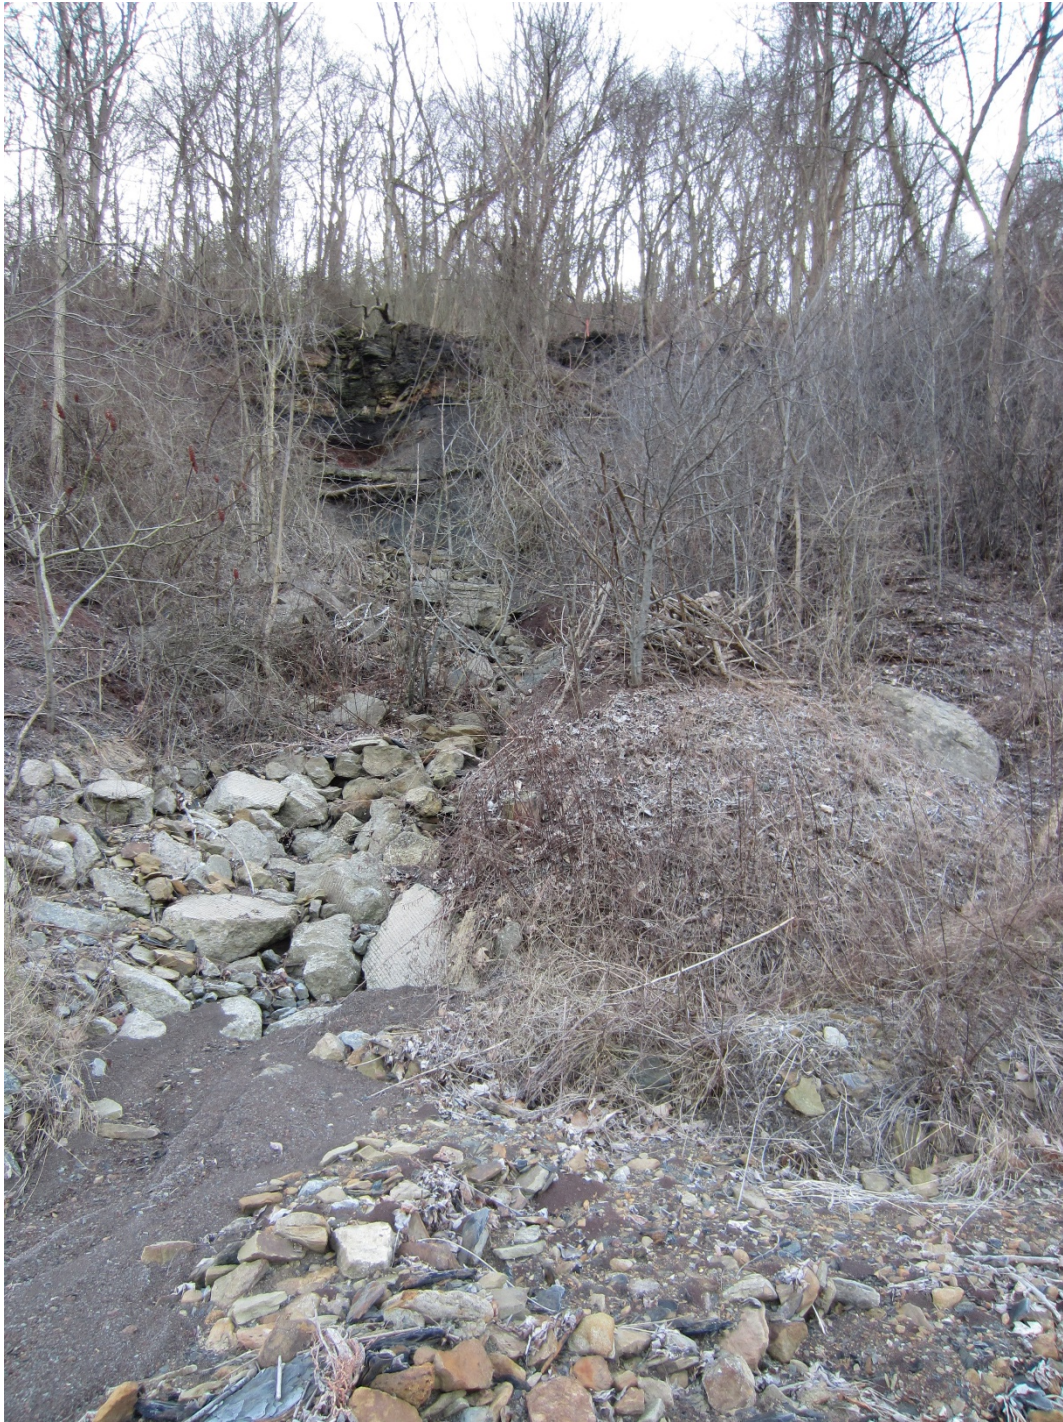
Overall view northeast at the eroded ravine Sta 976.

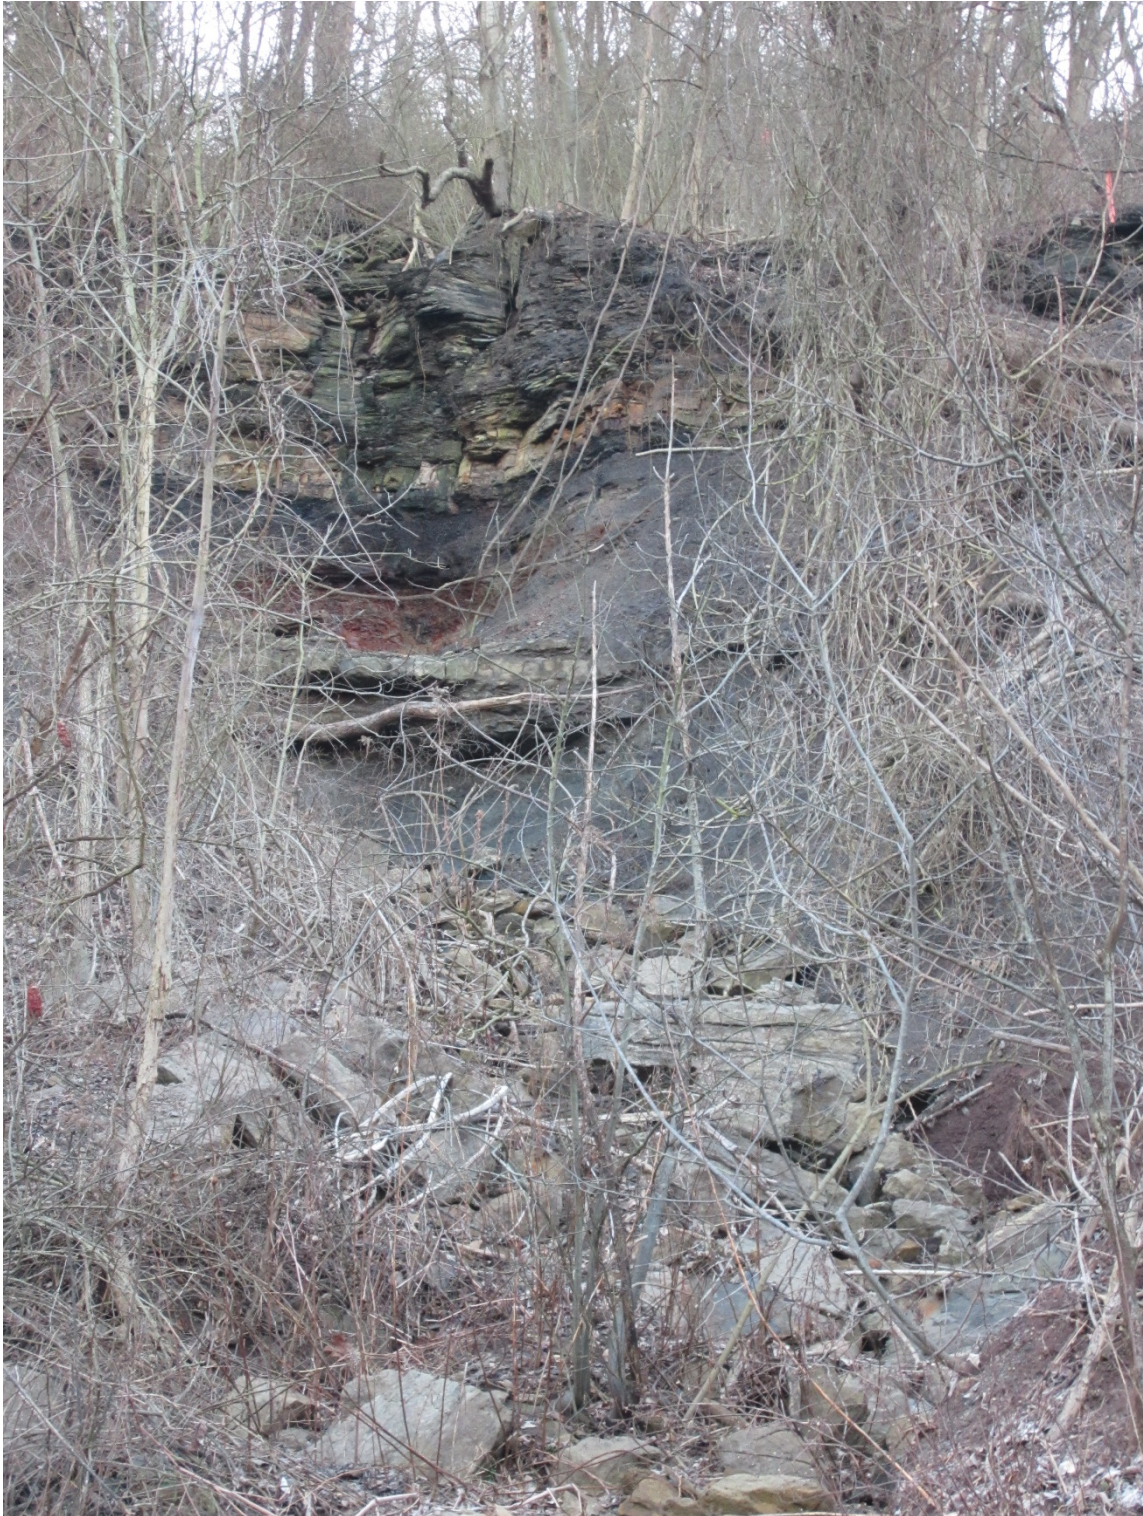
Closer view northeast at the eroded ravine at Sta 976.

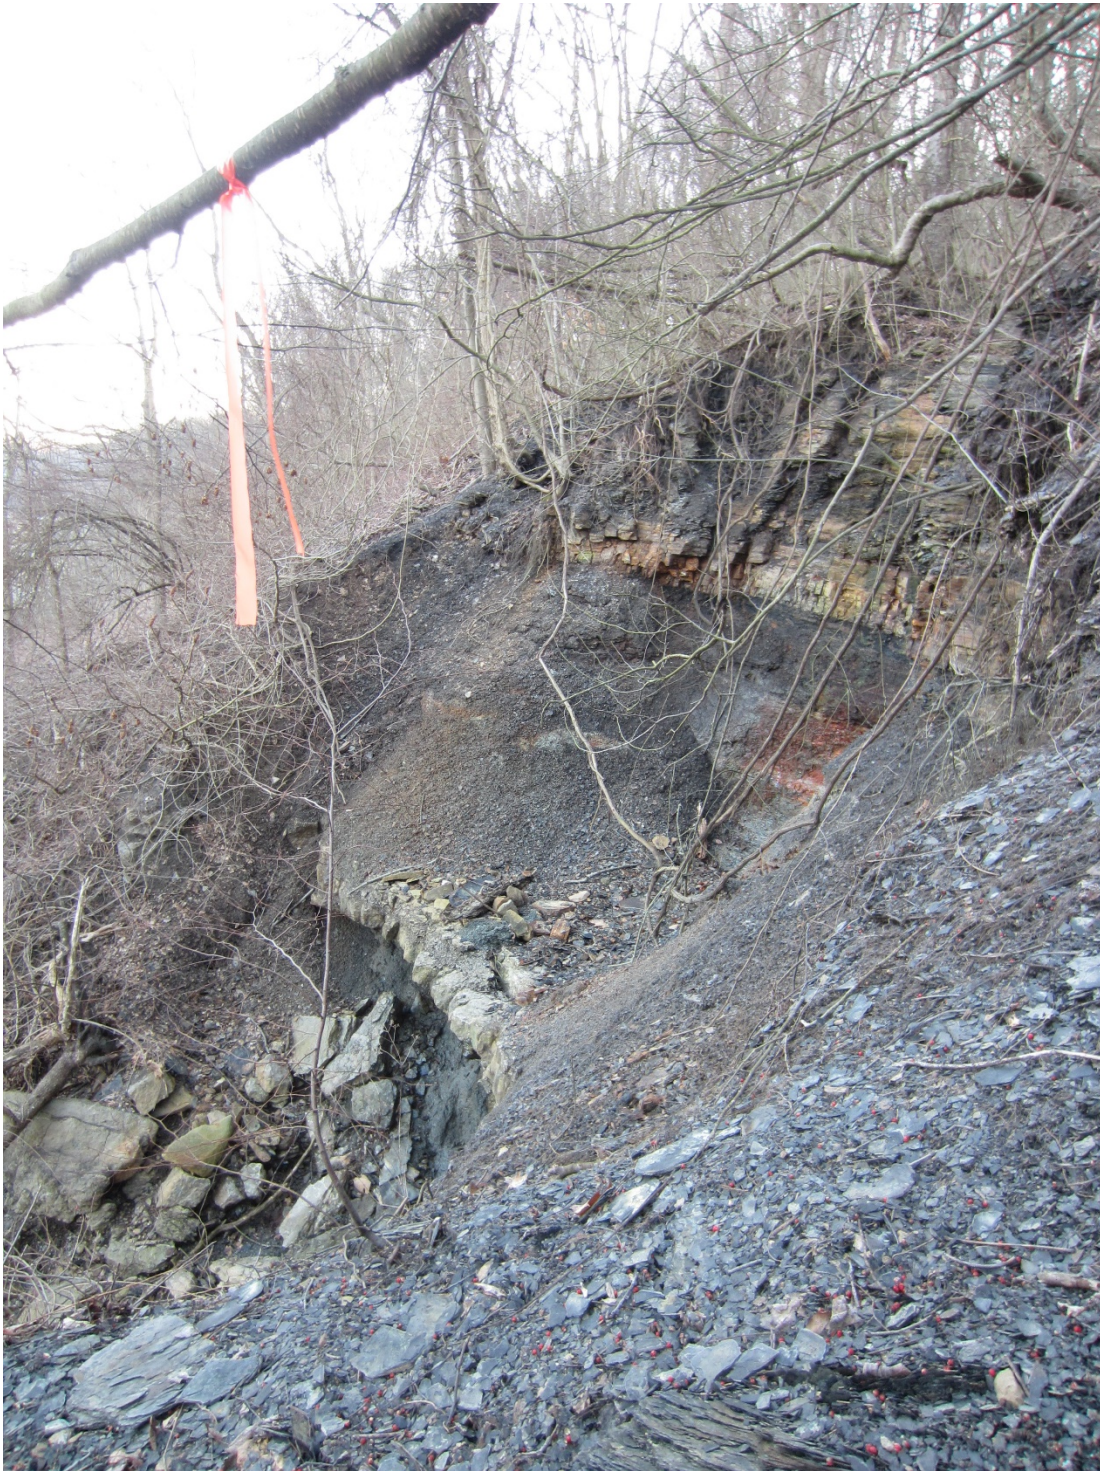
View north at the upper part of the eroded ravine, Ames Limestone up to Duquesne coal – strata dip 7° into the slope – apparently slumped.

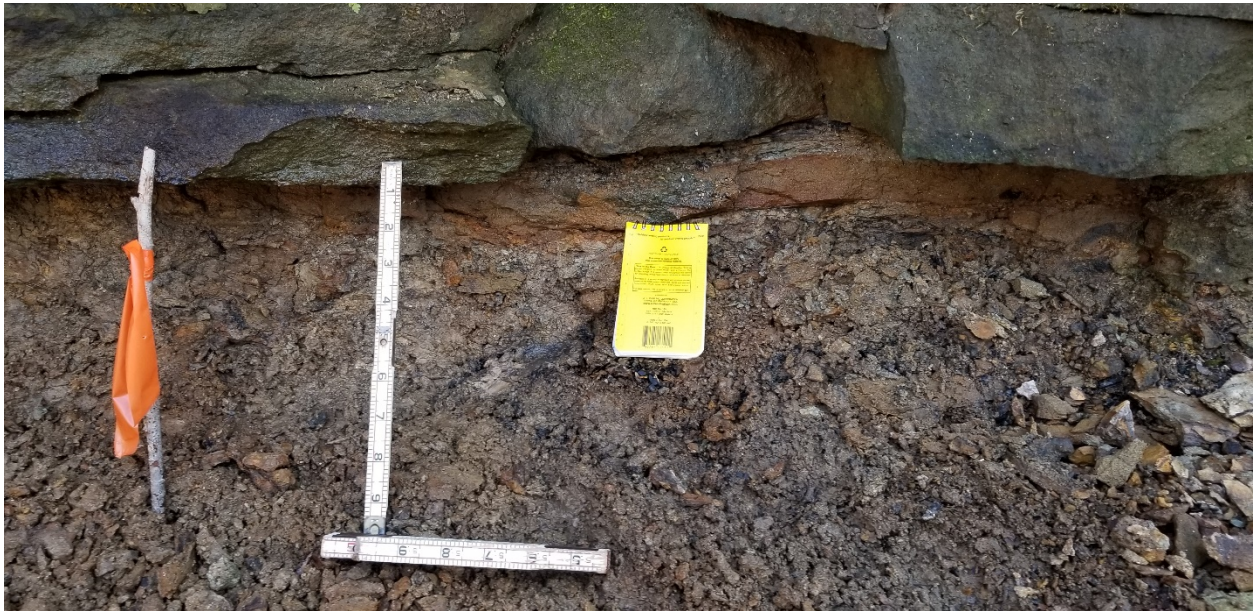
Base of the Morgantown sandstone in the upper part of the eroded ravine. The stick with the orange flag is at the 1/2 in. thick Wellersburg coal.

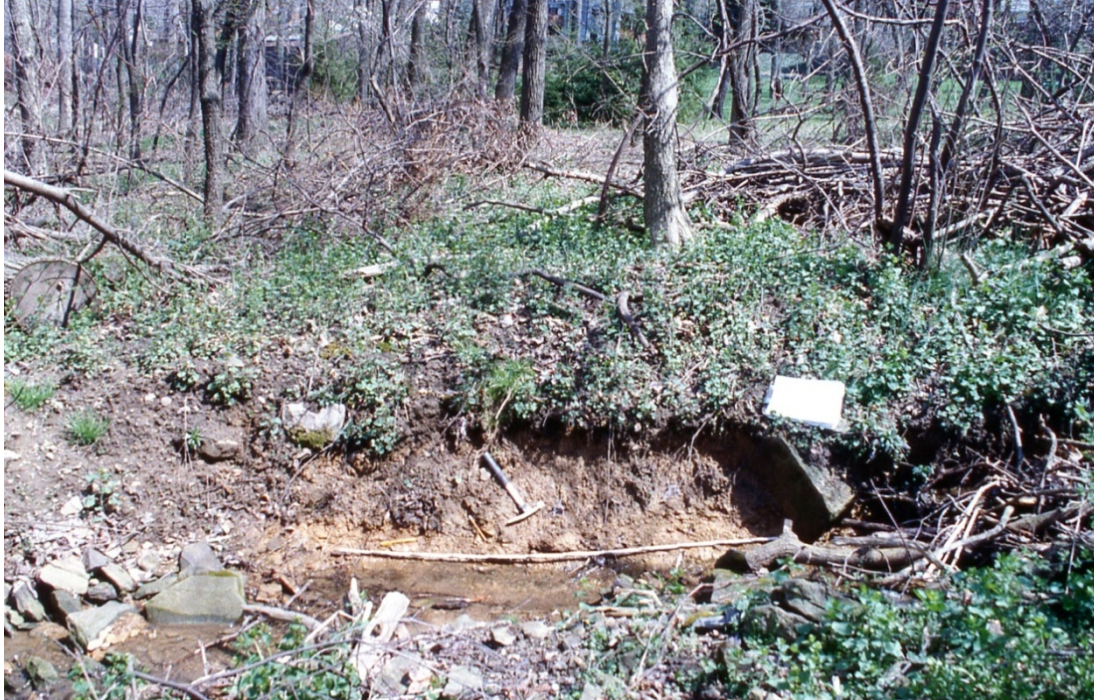
Sta 975 upslope of the eroded ravine – overall of slackwater soil at approximate el. 1116 ft.

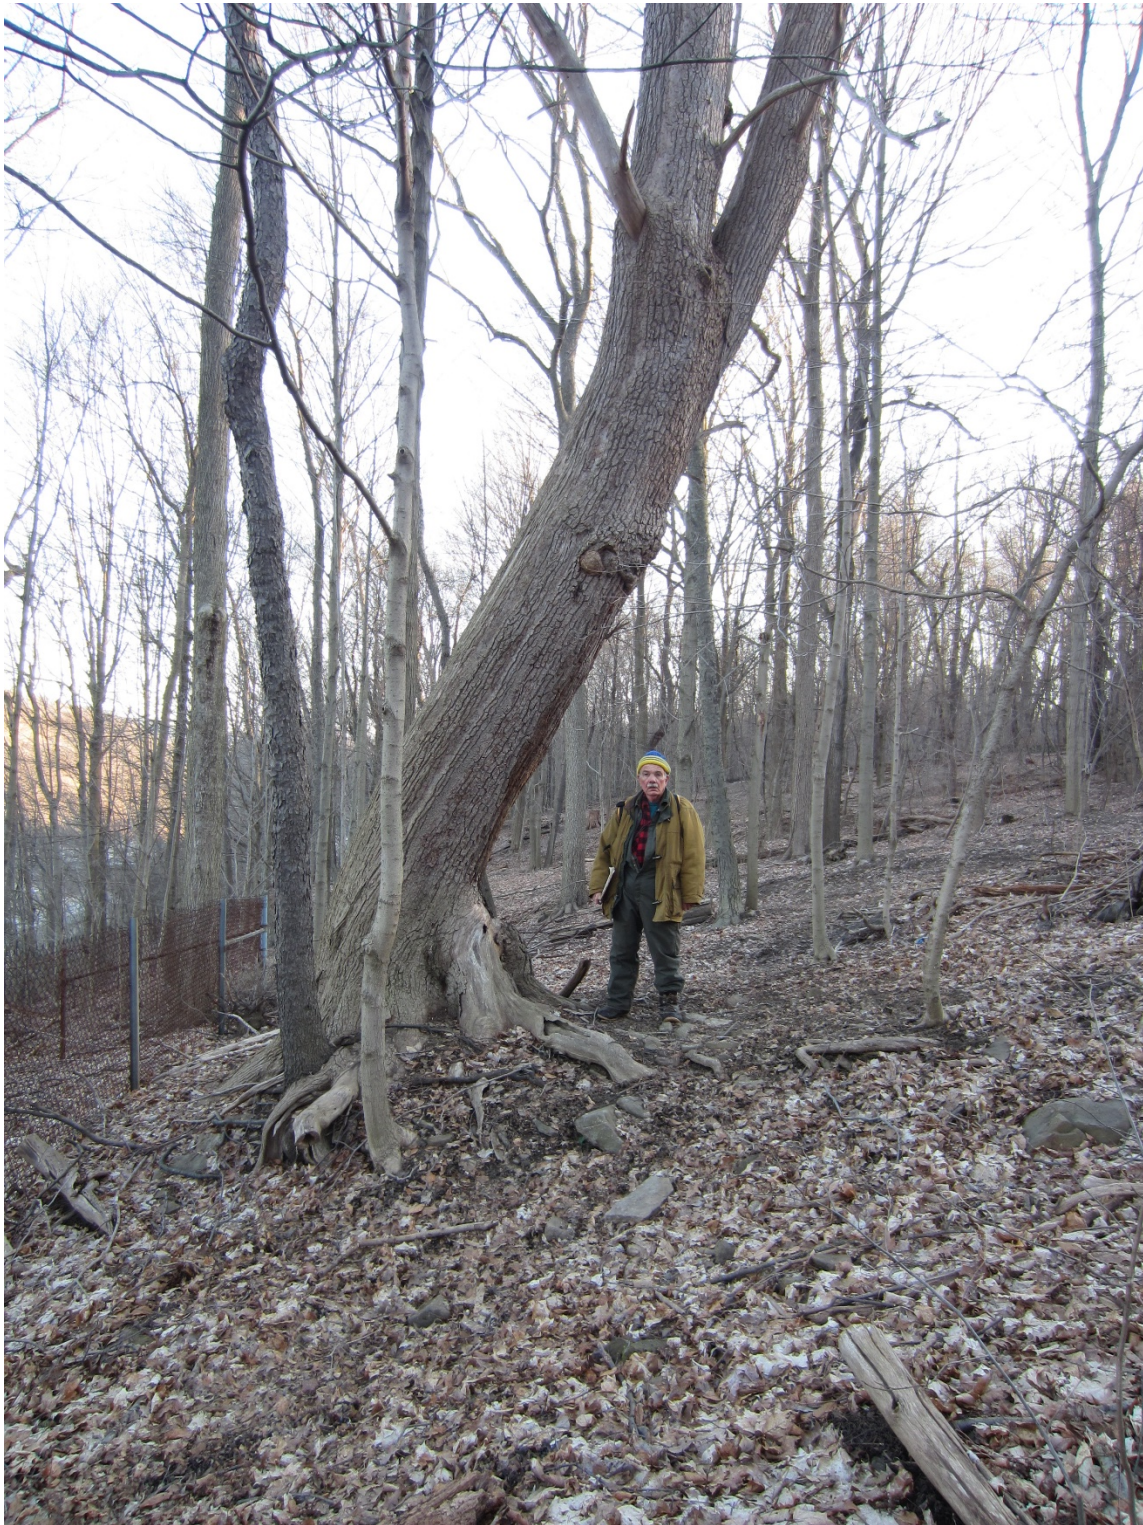
Jim Hamel at bent trees along the right of way fence just north of the eroded ravine.

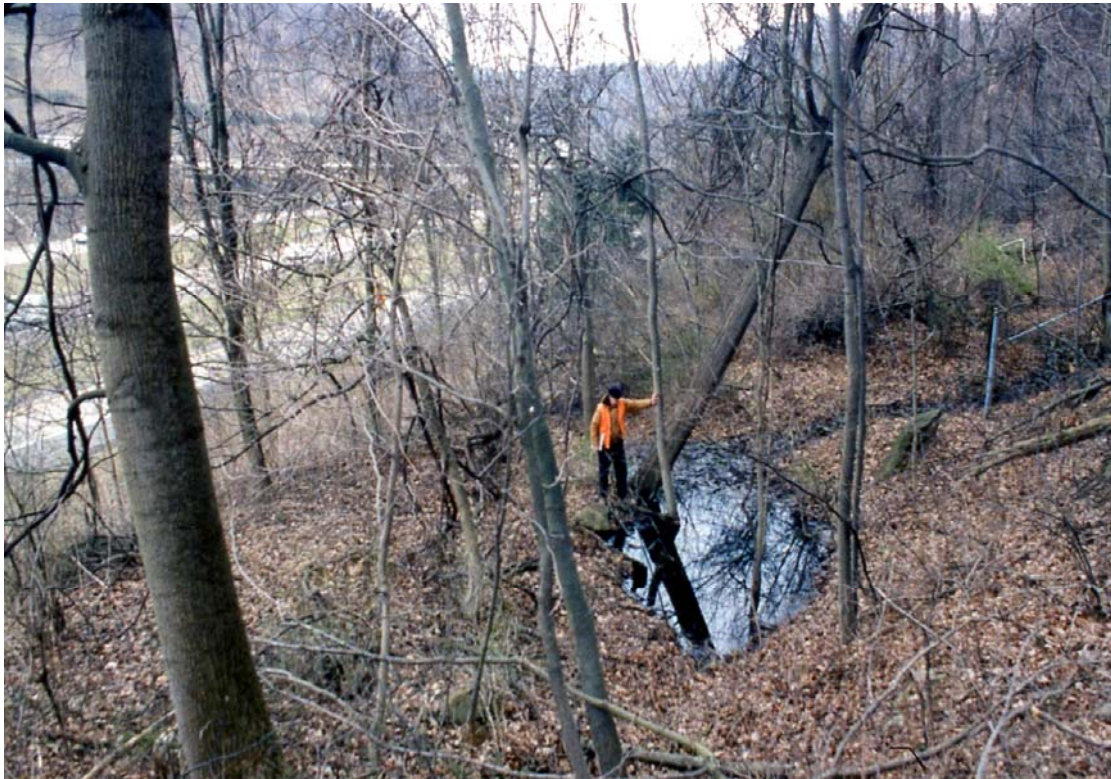
Mike Forth at a depression pond in colluvium above the Mt. Nebo exit ramp.

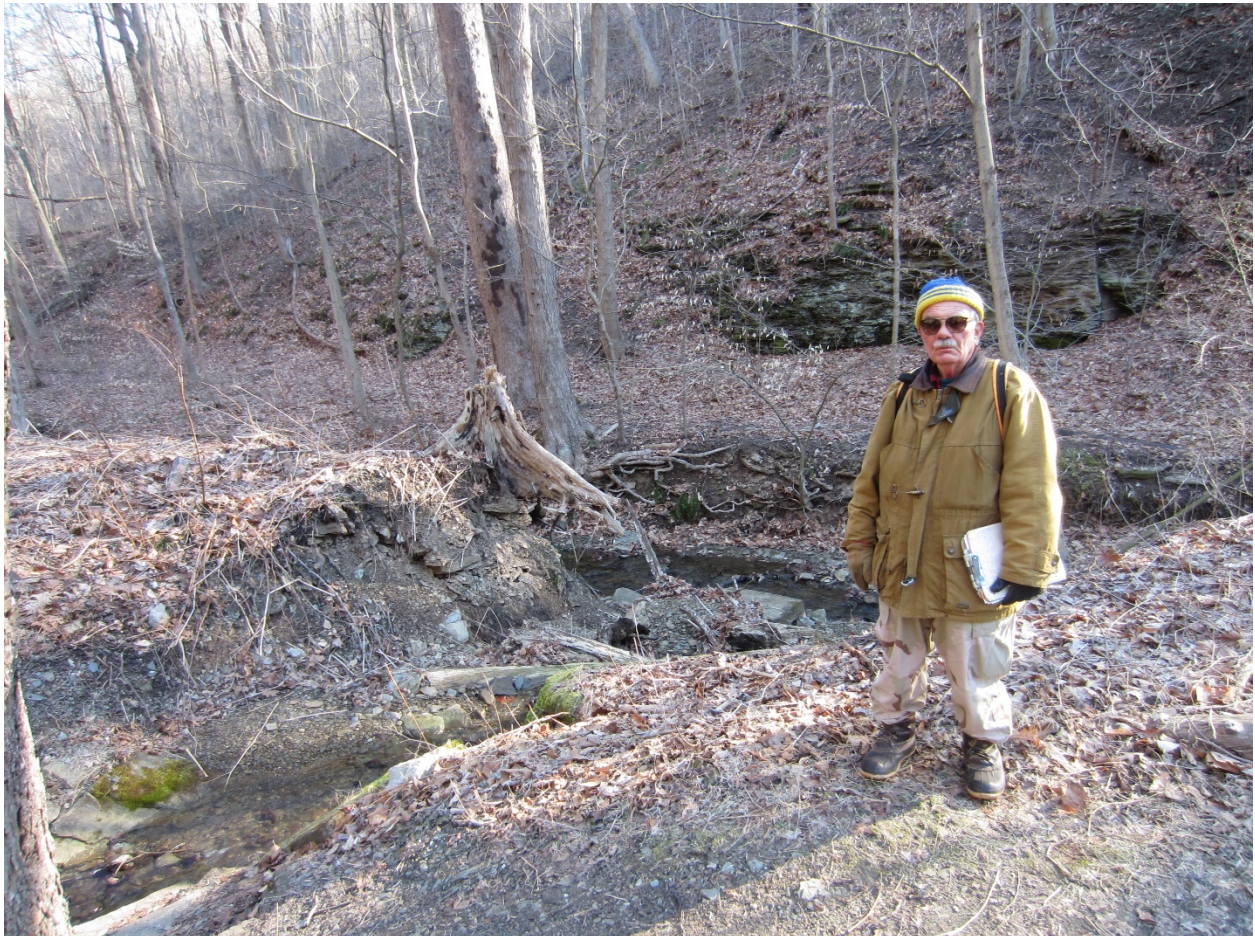
Jim Hamel at the confluence of third and second order tributaries of the Ohio River. Saltsburg shale and sandstone are exposed in the far bank of the second order tributary.

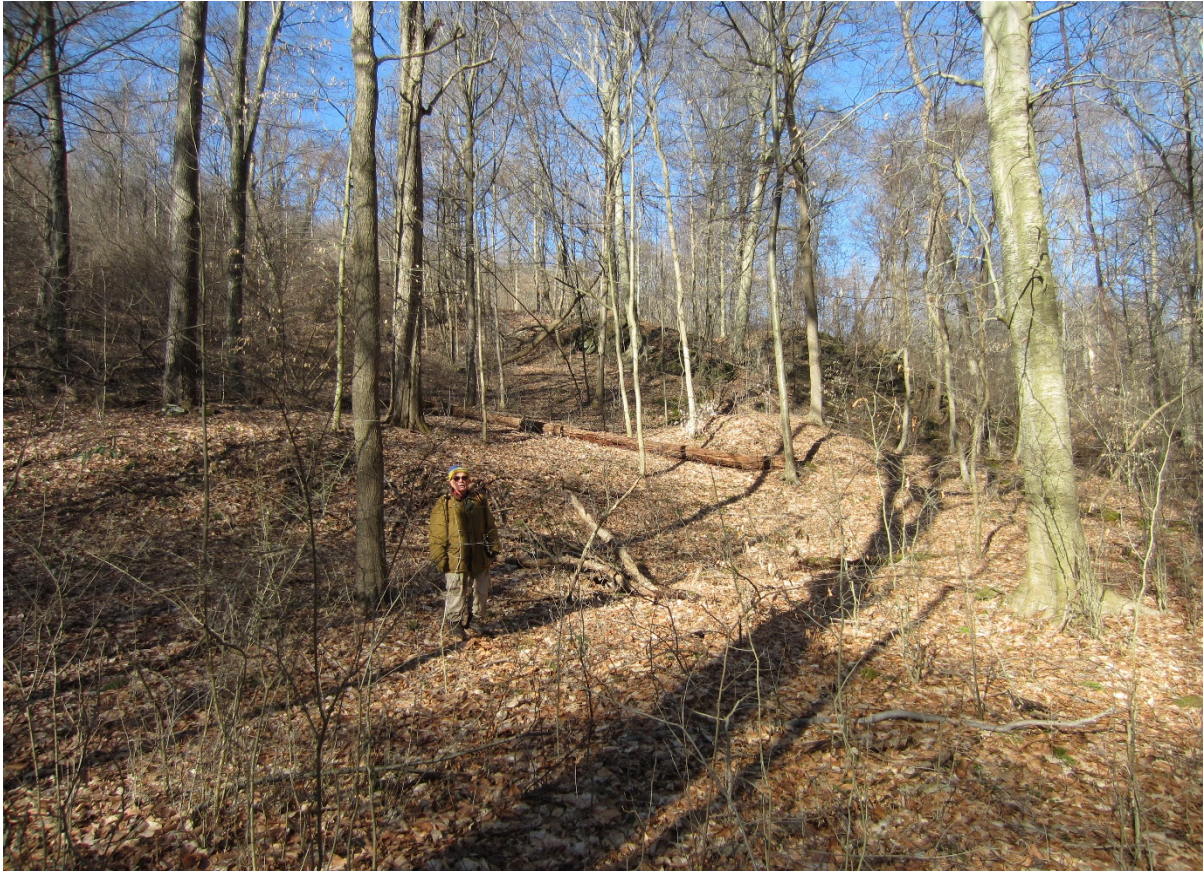
Jim Hamel at a lobe of slide debris on the south side of the third order tributary valley.

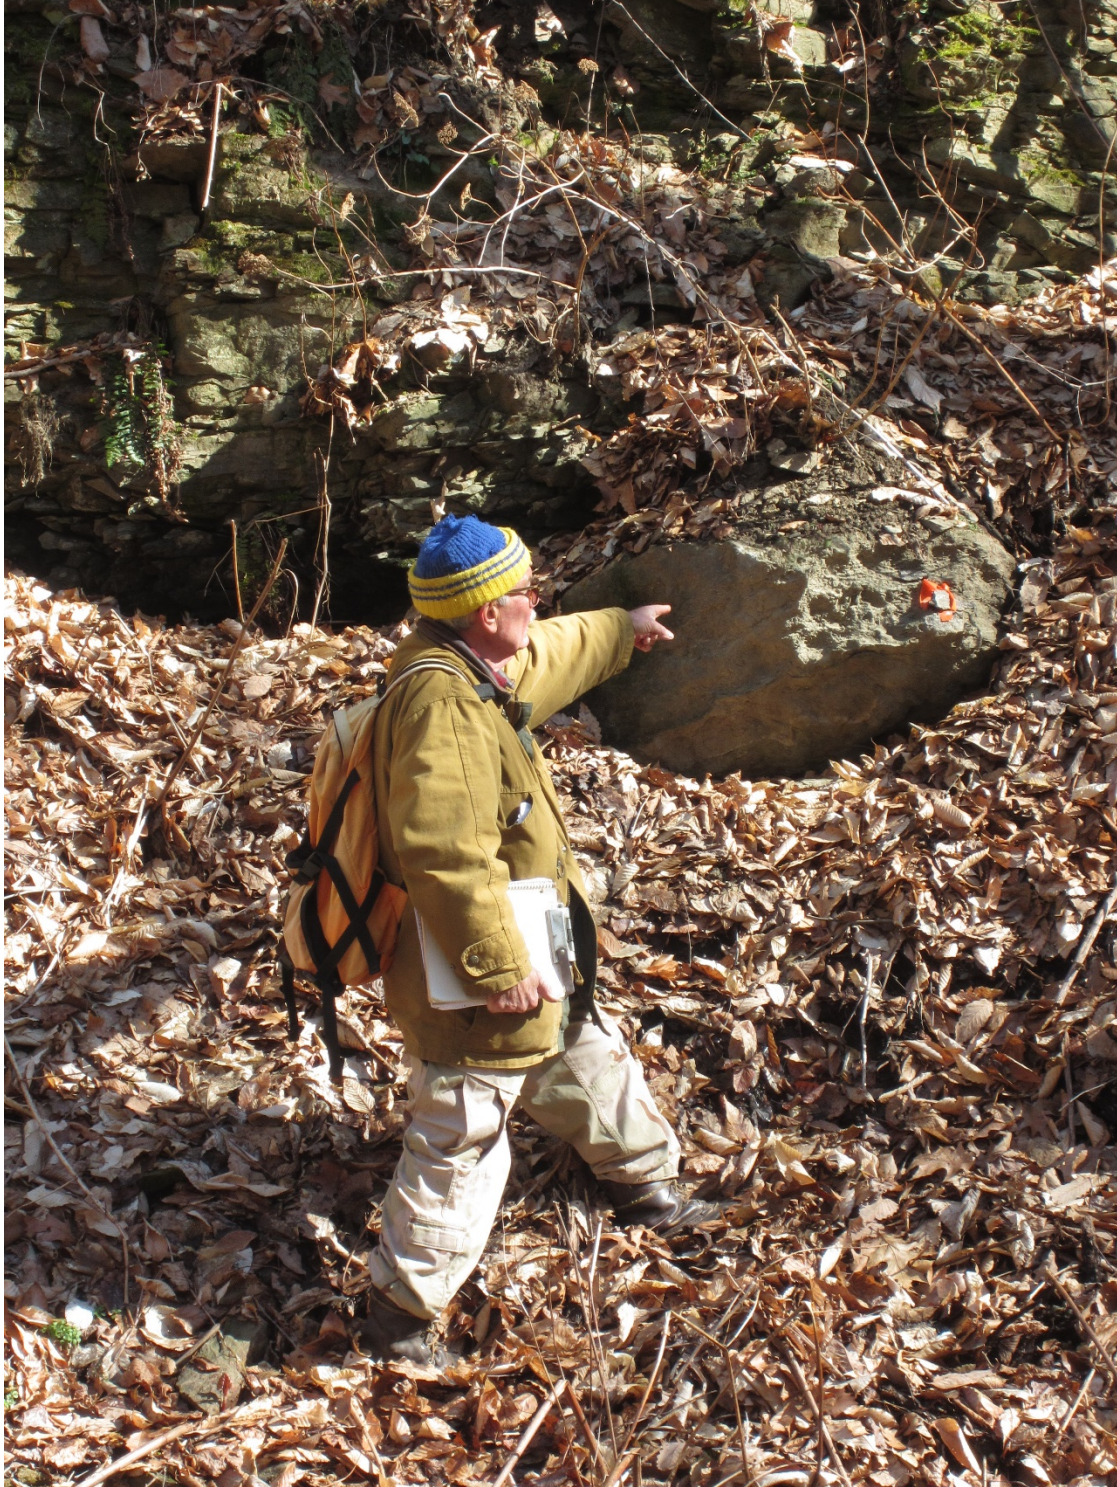
Jim Hamel at a slumped Ames Limestone boulder on the slope on the north side of the stream.

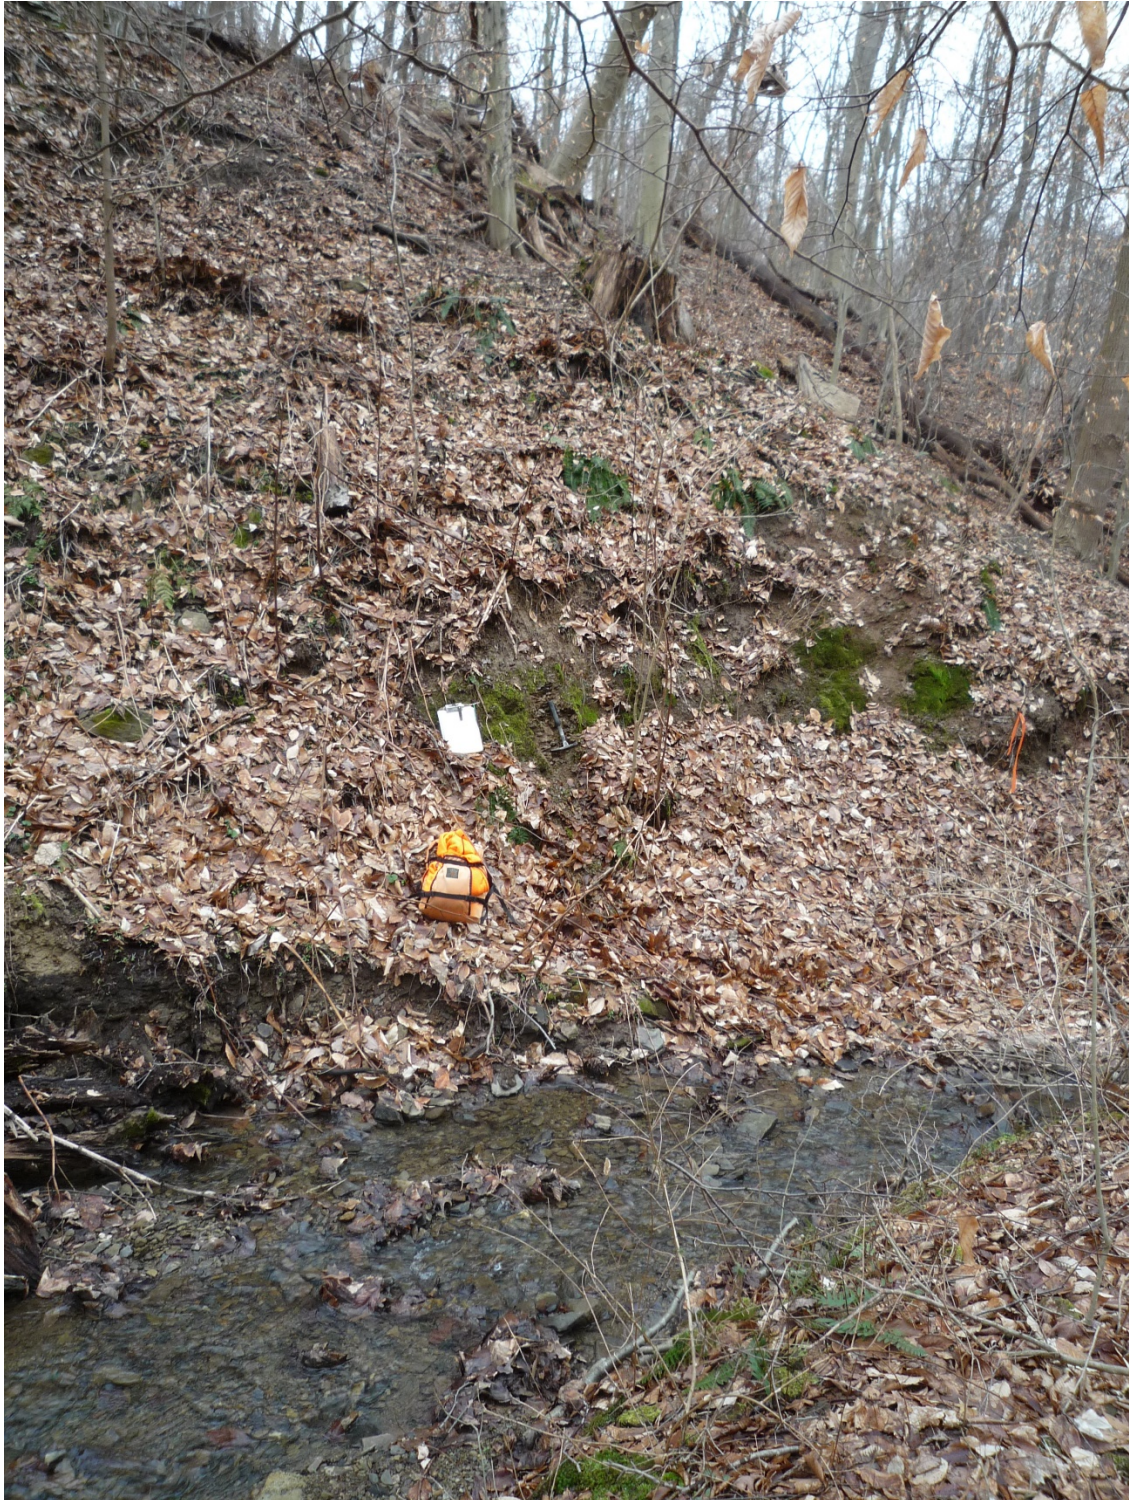
Overall view of slumped Pittsburgh red beds shaly claystone on the slope on the north side of the stream at approximate el. 980 ft.
