Pittsburgh Geological Society
75th Anniversary Field Trip
March 2022

Interstate Route 79 and Toms Run Nature Reserve
Landslide Areas North of the Ohio River and
Northwest of Pittsburgh

I-79 Station 916-918 Progressive Failure of Colluvial Slope – March 13, 1969

Field Trip Leader: James V. Hamel, Ph.D., P.E., P.G.
PGS Honorary Member

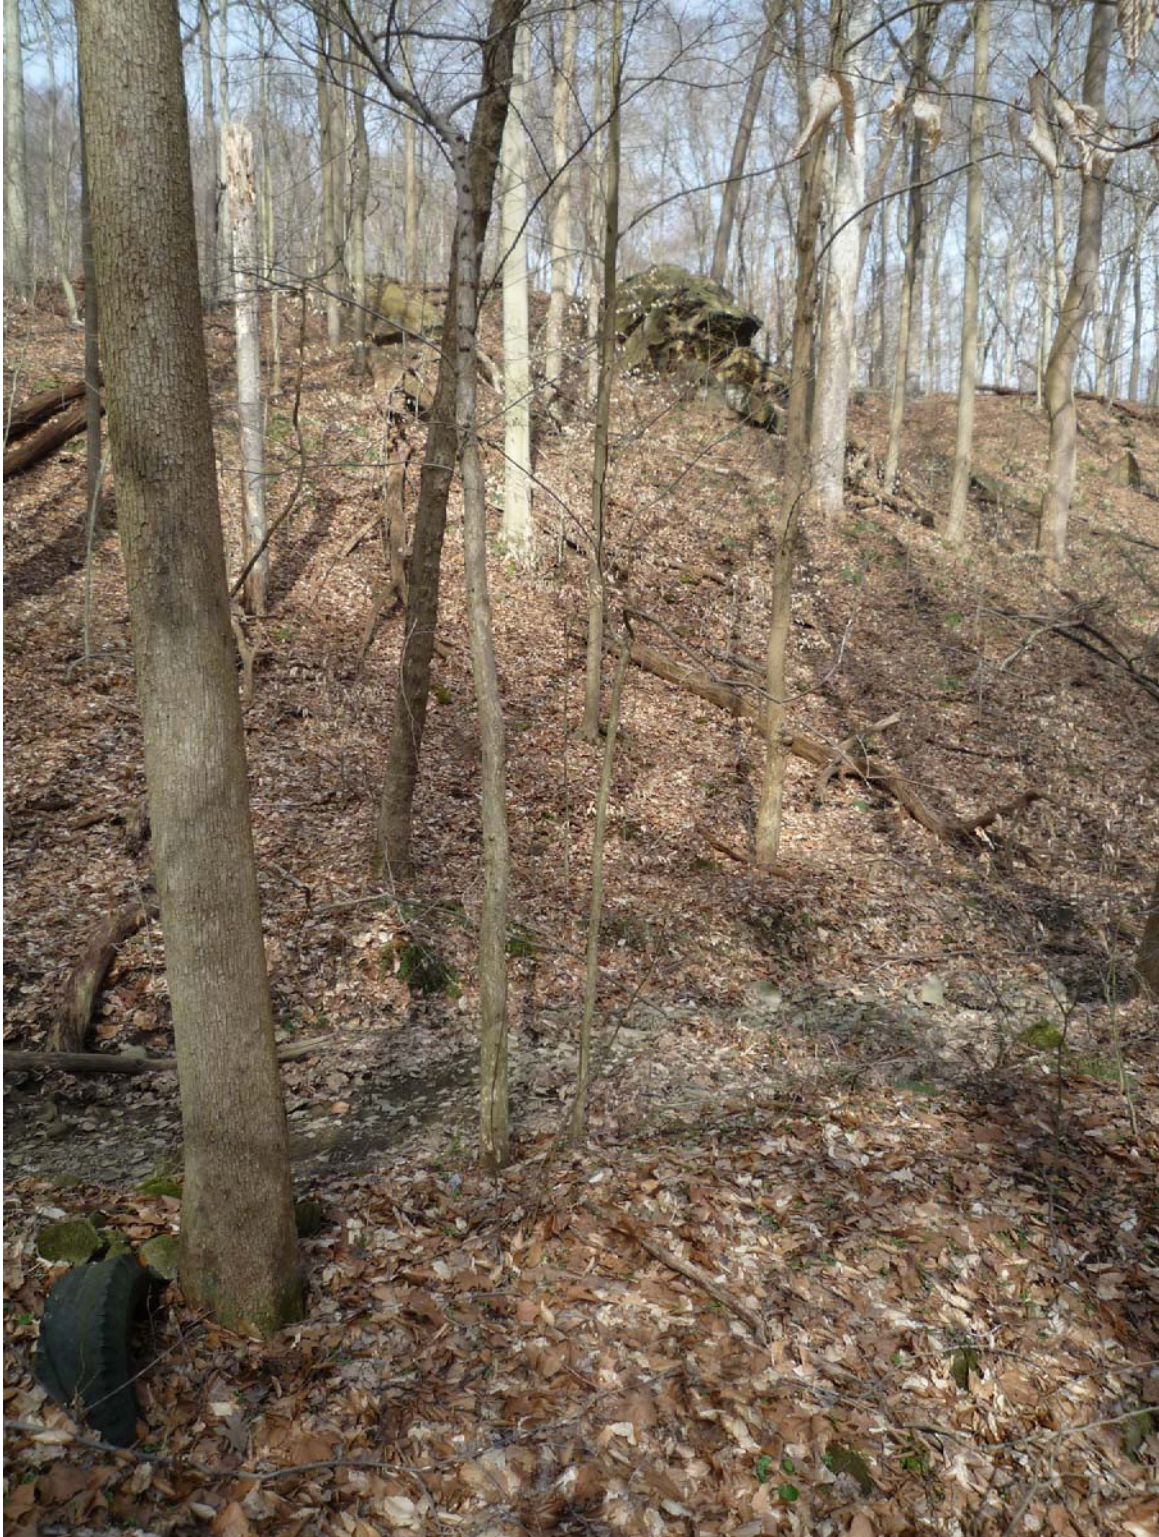
Overall view of a huge Morgantown sandstone slump block on the north side of the valley at approximate el. 1000 ft.

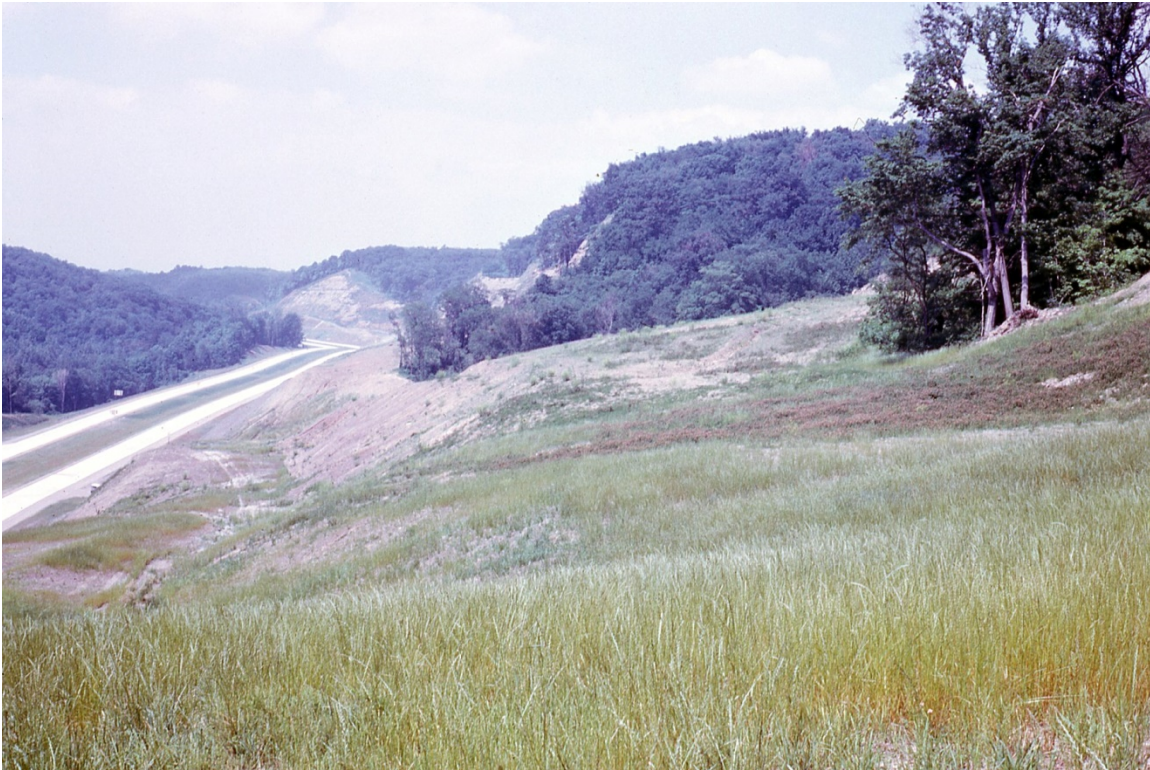
View north from approximate Sta 895 at the excavated slide debris above the lower excavated bench on top of the Saltsburg shale and sandstone.

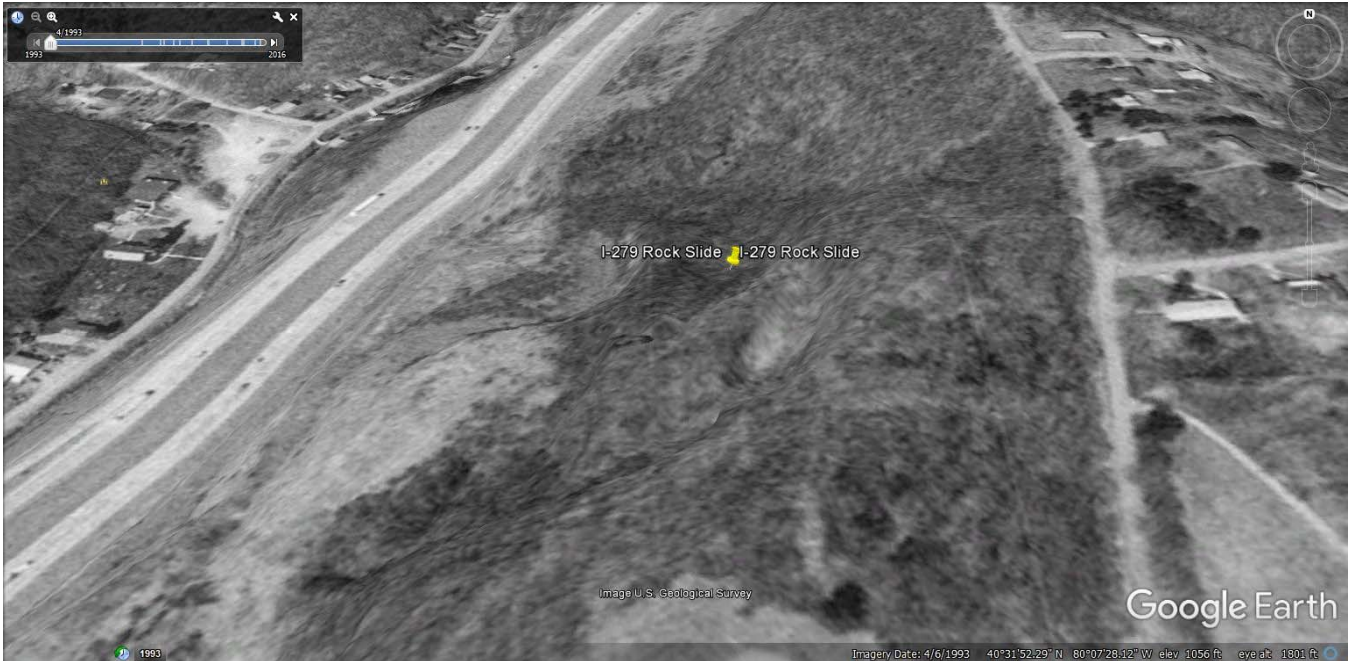
Google Earth photo looking north at the slide area, approximate Sta 902-910. The graben is on the right and below the yellow tack.

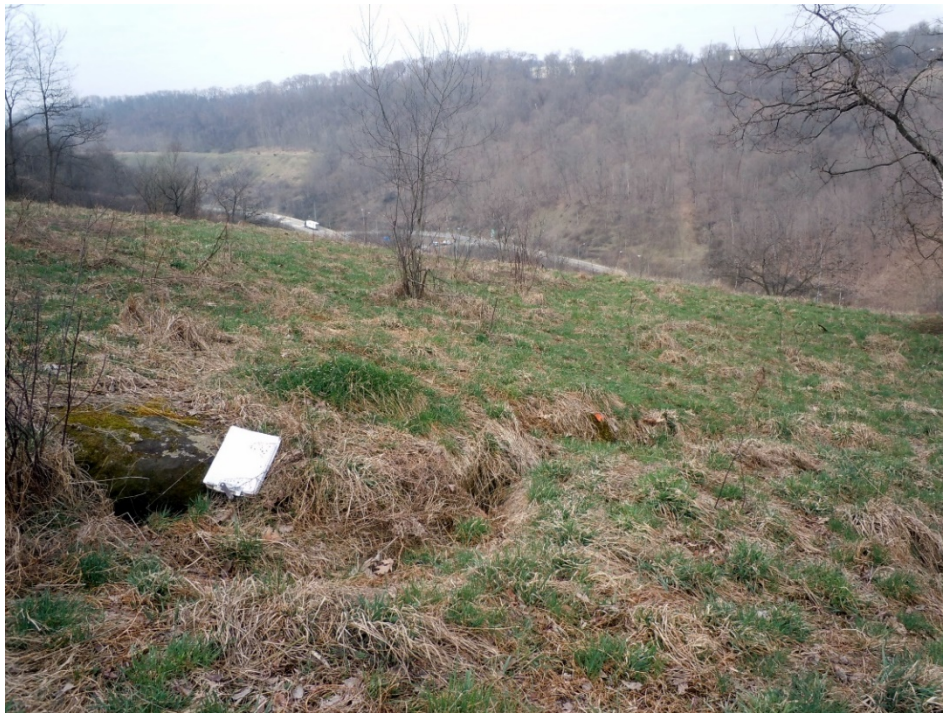
View southwest at the cracks between sandstone slide blocks. Clipboard for scale. Approximate Sta 907.

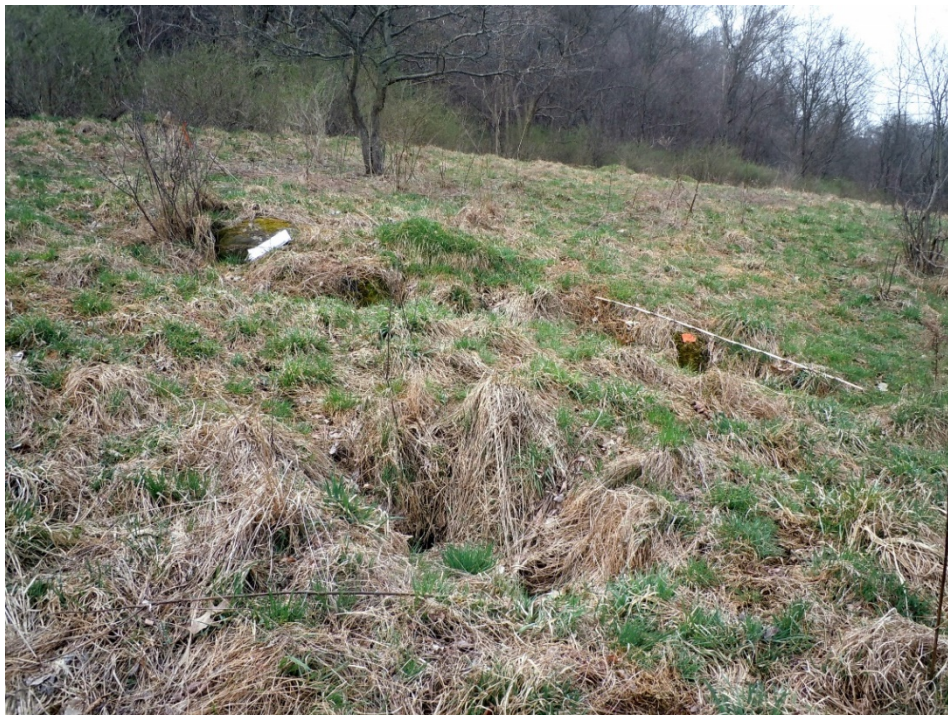
View southeast at the above cracks. Clipboard and 6 foot rule for scale.

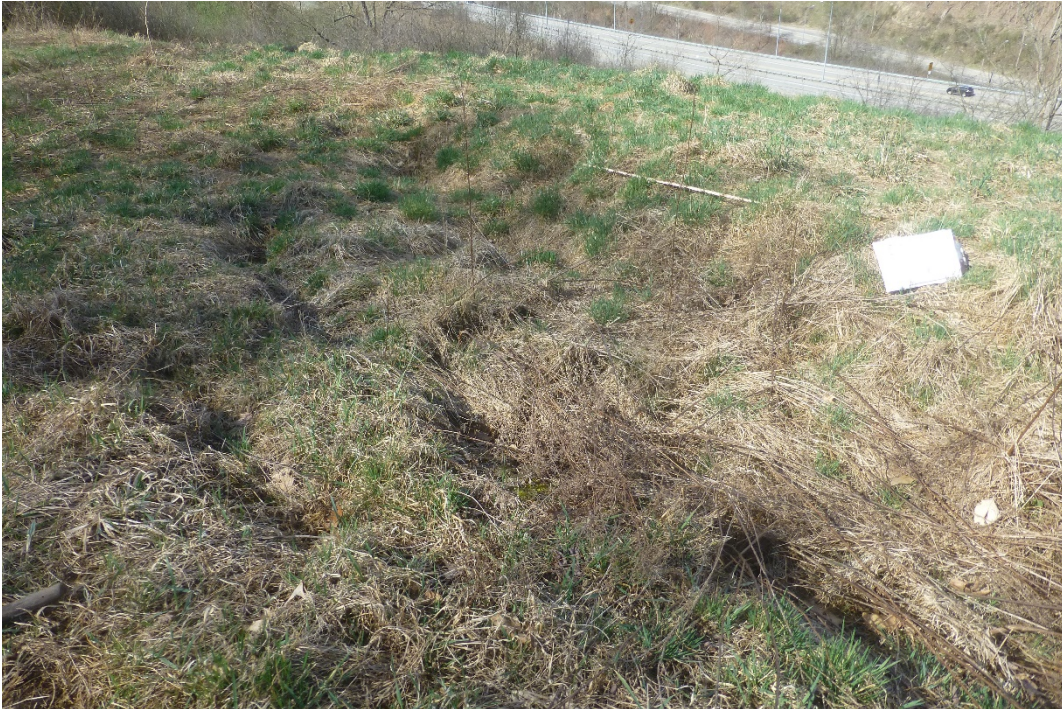
View southwest at the cracks in the slide debris. Clipboard and 6 foot rule for scale. Approximate Sta 904.

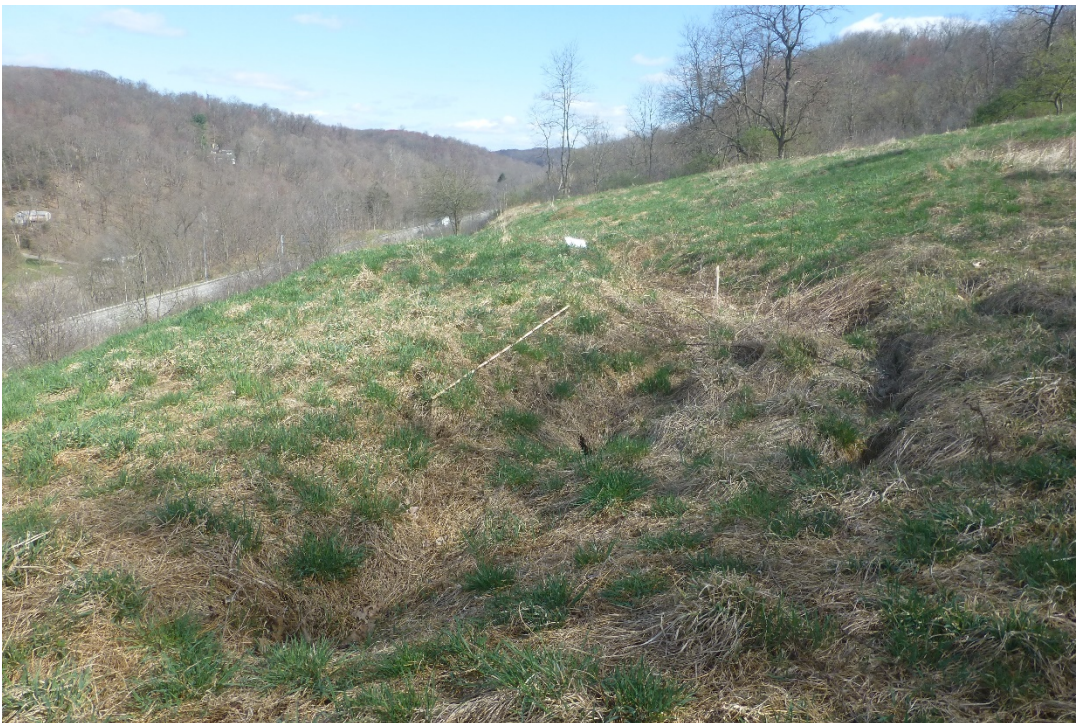
View north at the above-mentioned cracks. Clipboard and 6 foot rule for scale.

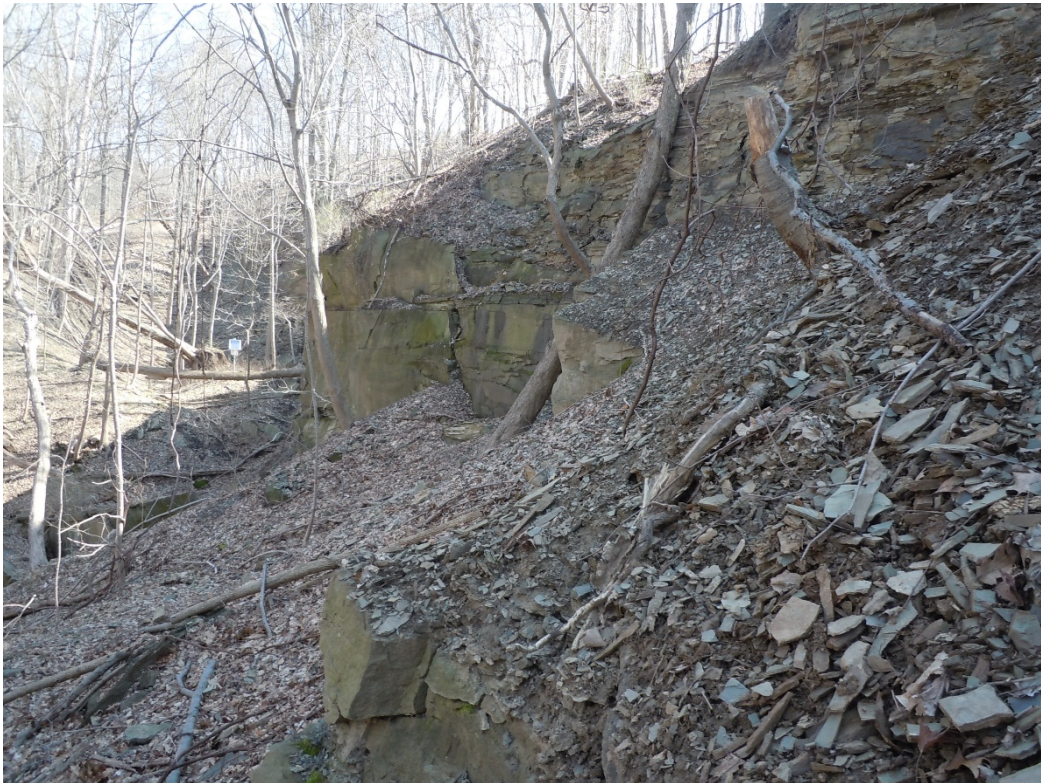
View north along the slide scarp from approximate Sta 904. The graben is at the top left.

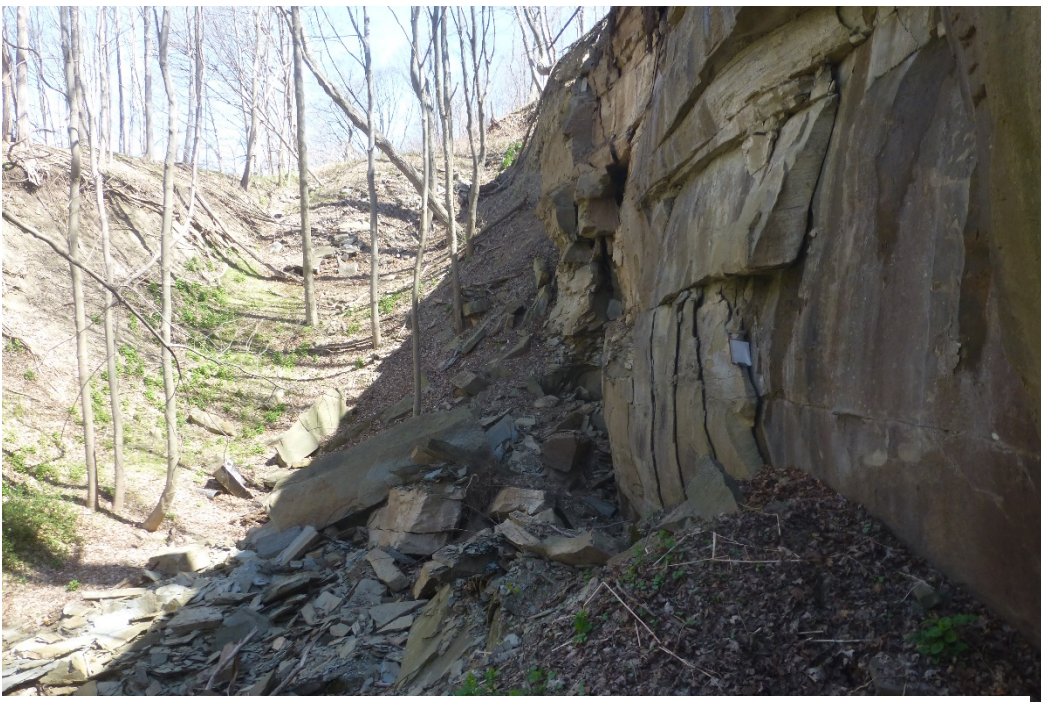
Closer view north along the scarp and graben.

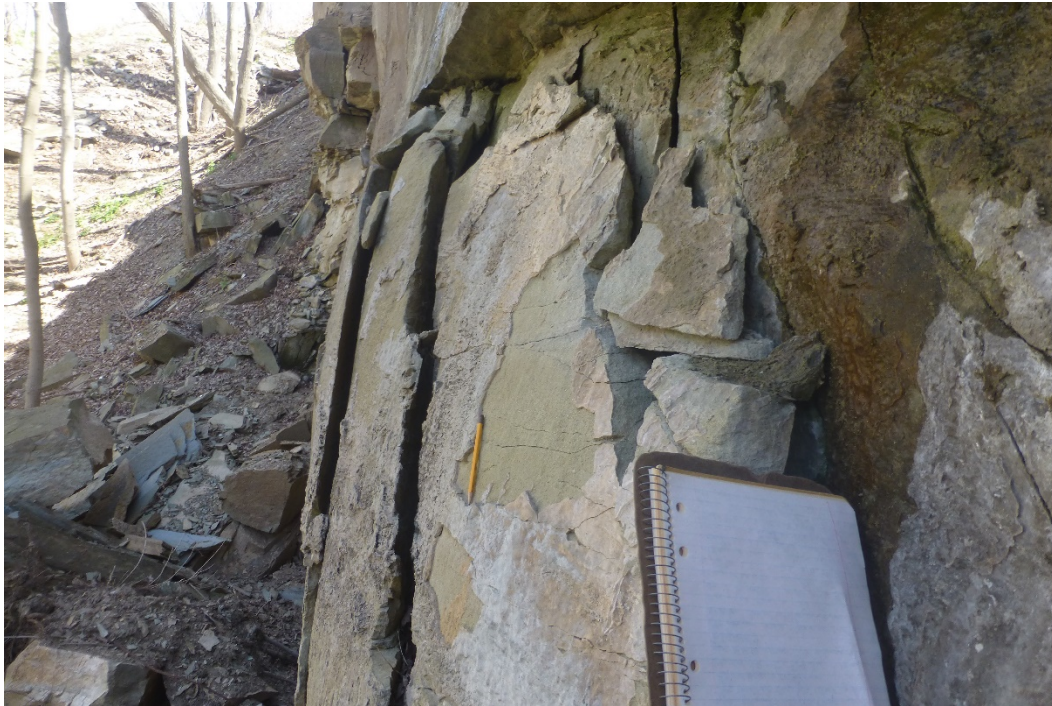
Calcite joint filling in the right center of the previous photo.

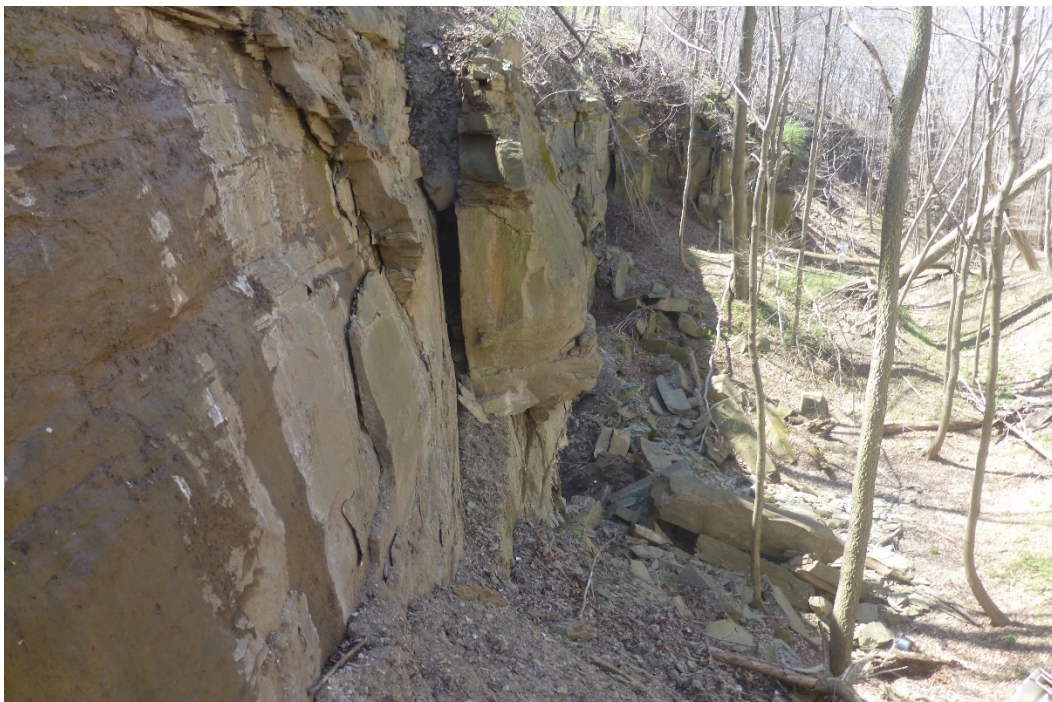
View south along the scarp and graben from approximate Sta 908.

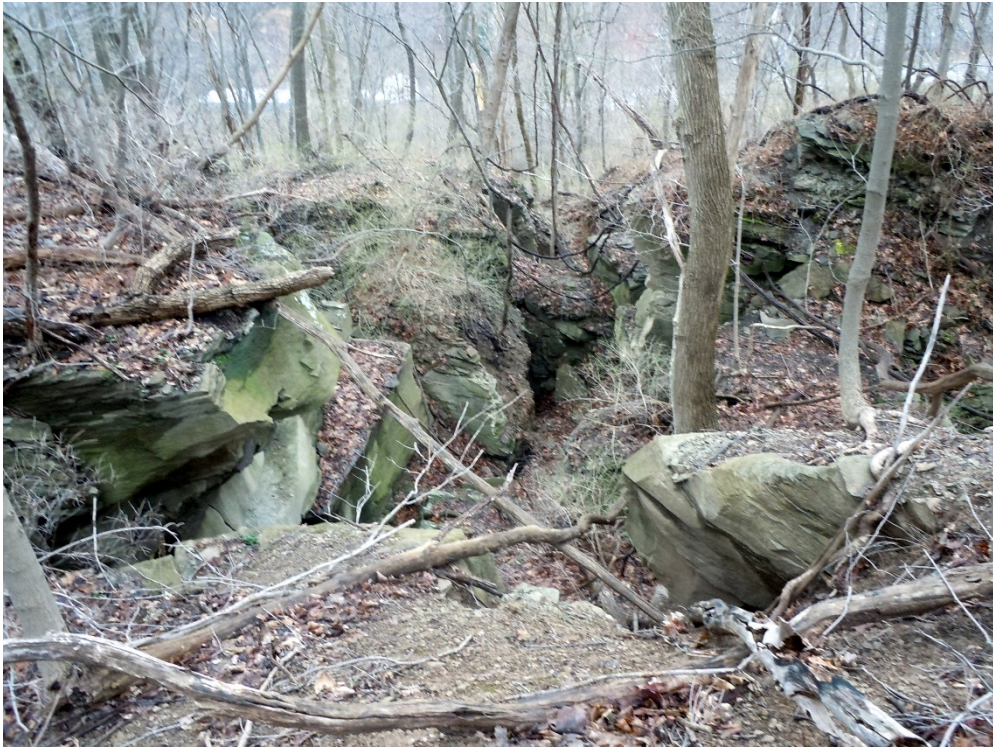
View west at sandstone slide blocks west of the graben at approximate Sta 907.

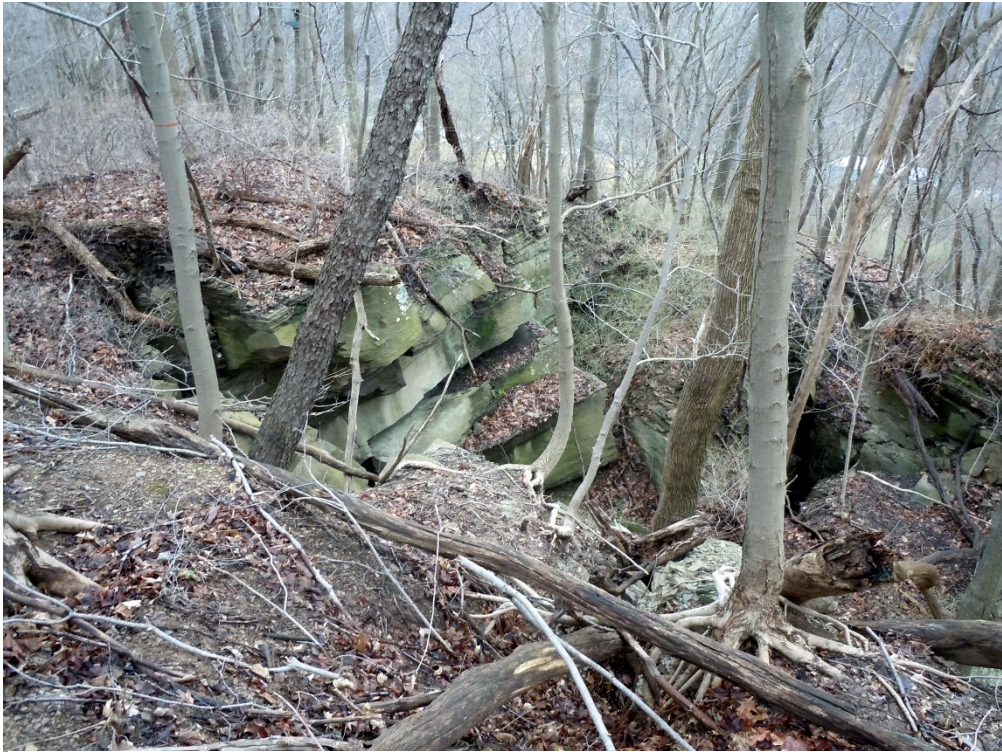
View south at the intermediate scarp in the previous photos.

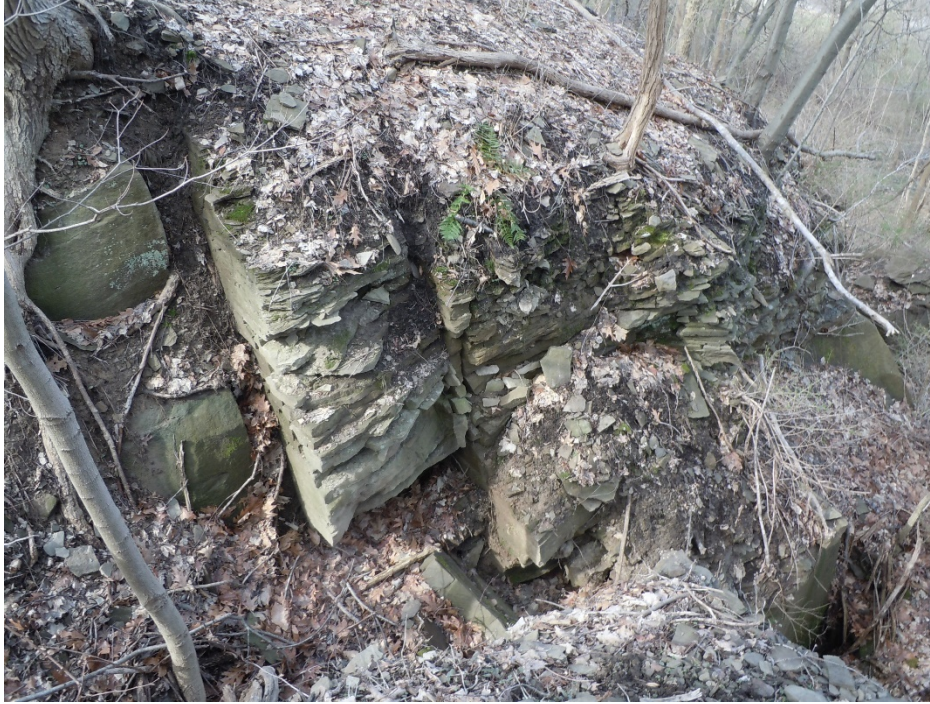
View south at the slide fissure at approximate Sta 906.

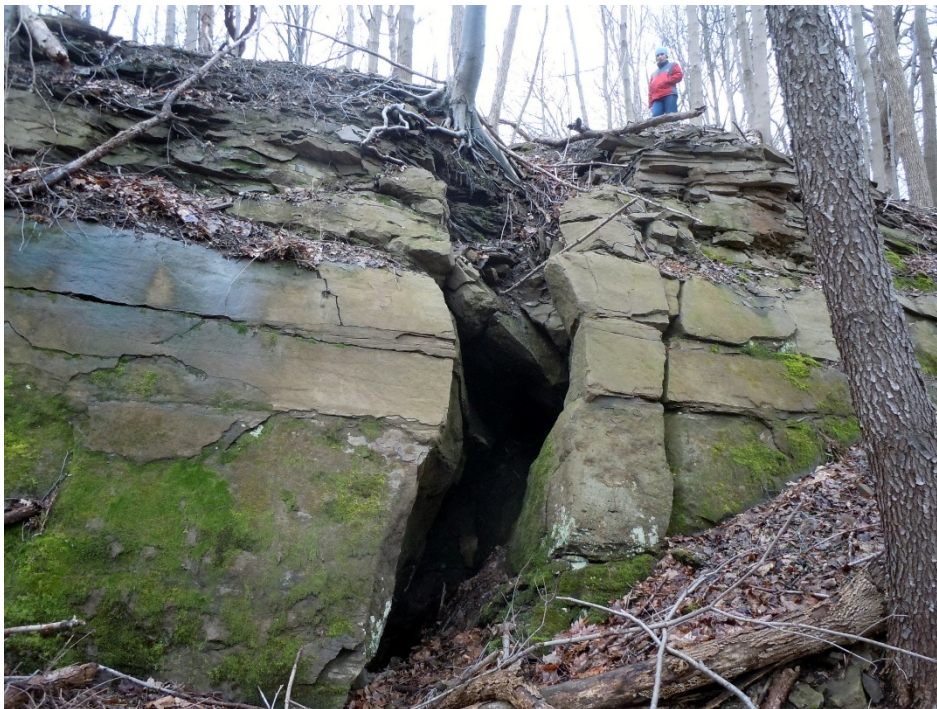
View east at the front face of the sandstone slide blocks (intermediate scarp) at approximate Sta 905.
