**Guidebook for the
PITTSBURGH GEOLOGICAL SOCIETY**

**The Geology, Environmental Geology, and Engineering
Geology
Of Western Allegheny County, Pennsylvania**

ENGINEERING GEOLOGY AND FOUNDATION DESIGN FOR THE BRADDOCK DAM IN-THE-WET CONSTRUCTION PROJECT

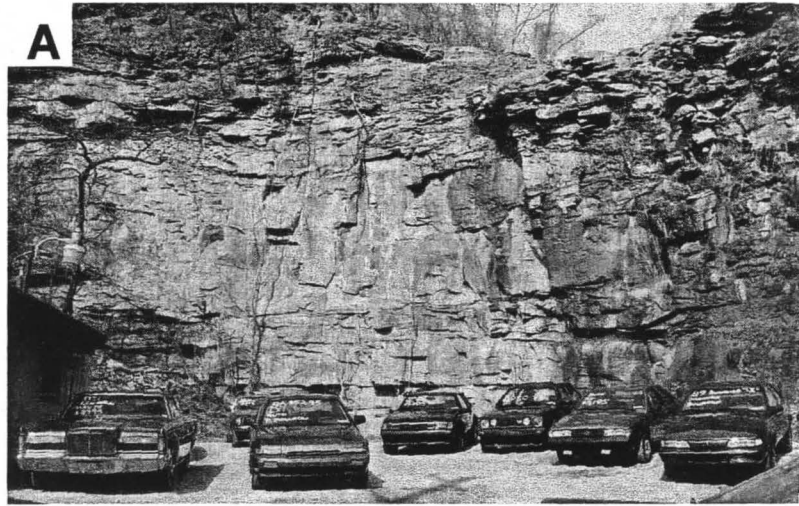
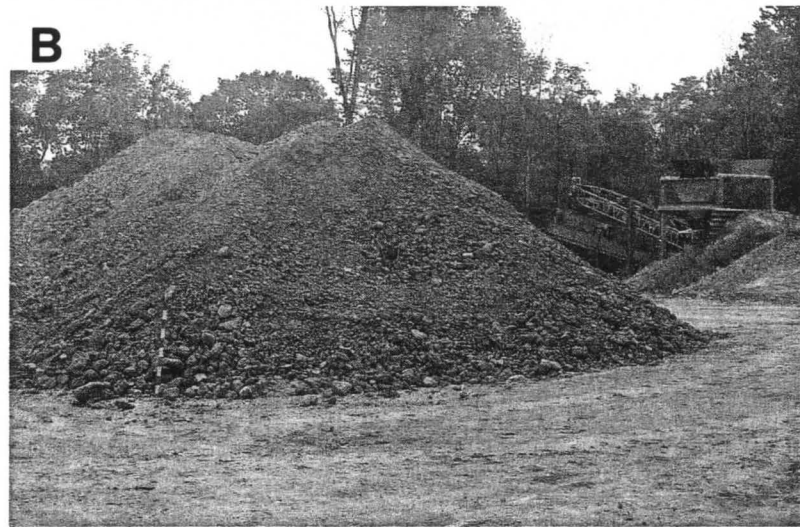
Figure 9. Photos of some of the non-fuel mineral resources found in Allegheny County. A. Sandstone – this particular quarry has been long abandoned, but others are still in operation. B. Sand and gravel – most resources are dredged from the rivers, but some terrace deposits still exist to be exploited. C. Slag – the latest “rock” type to gain acceptance as a commercially viable mineral resource.

A more recent “mineral resource”, slag has stopped being simply an eyesore in western Pennsylvania. Old slag dumps now command the attention of companies such as Lafarge and International Mill Service who are quarrying them for a number of purposes. The large slag dump in West Mifflin, Allegheny County (Figure 9C) now boasts a shopping mall and two shopping centers, as well as a “gravel” quarry. Quarrying operations in this dump, and others in Beaver and Westmoreland counties, provide fine aggregates, railroad ballast, PennDOT approved Type C coarse aggregates, PennDOT approved skid-resistant level H aggregates, and general fill (Barnes, 1997) (although, the District 11-0 office of PennDOT currently prohibits the use of slag for use beneath roads and road shoulders). Another slag dump on Nine Mile Run in the Squirrel Hill section of Pittsburgh is currently being graded and covered with topsoil in an effort to develop it as an upscale townhouse community (see Stop 4).
